AN ENGINEERING GEOLOGICAL ASSESSMENT USING TERRESTRIAL LASER SCANNING FOR THE STABILIZATION OF A VOLCANIC SLOPE IN SANTORINI ISLAND.

Abstract

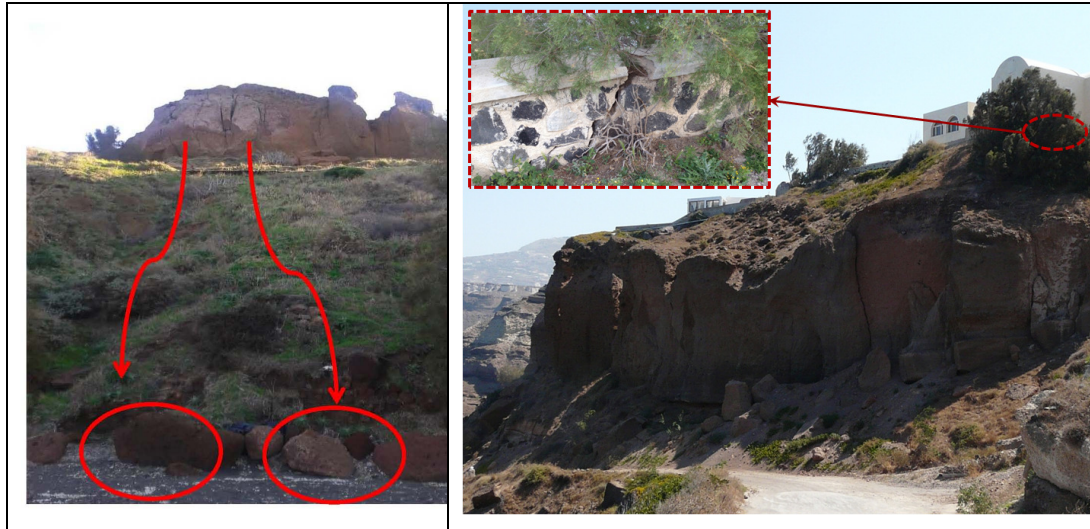
Figure 2. Blocks are likely to propagate downhill up to the sea level, passing twice over the local road and finally reaching the public beach. The rock block detachment may also create significant problems to the adjacent residences.

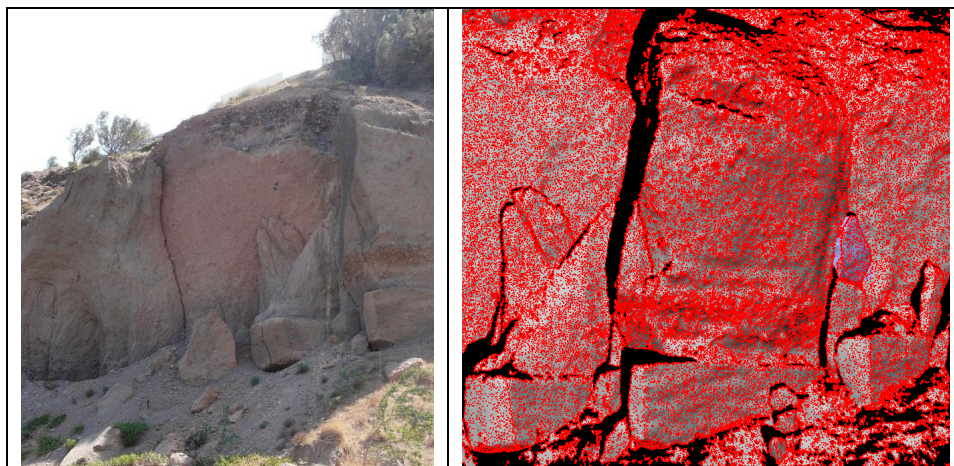
Figure 3. Point cloud of the area showing some of the unstable rocks and the developed tension cracks in detail.

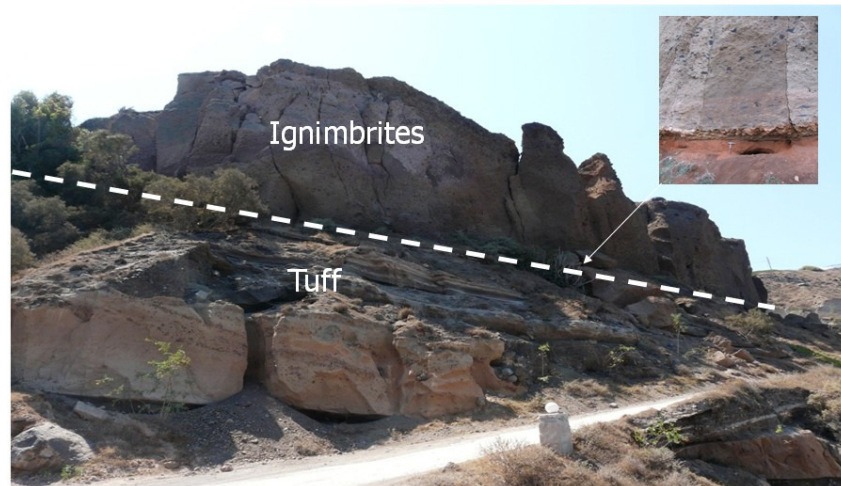
Ignimbrites have high strength but are based on soft and highly erodible tuffs and paleosol. Paleosol is composed of medium dense sandy material with clay. Water infiltrates along the joints of the hard rocks but stops along the impermeable tuffs. Thus, water softens the weak geomaterial, generates pore water pressure but also builds hydrostatic pressures along the open joints.

Figure 5. The differential erosion is caused along the contact of the hard ignimbrite columns and the looser paleosol. This weak surface of erosion generates tensile cracks that are extending with the force of water and wind with time. Picture in frame shows a detailed contact of the ignimbrite body on the paleosol.

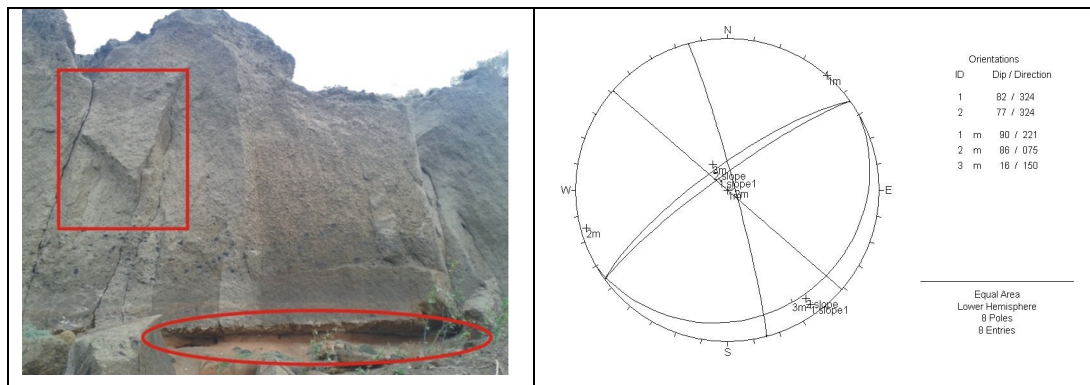
Figure 6. The paleosol and the underlied tuffs defined as the prime surface of the instability, is illustrated in the ellipse. The discontinuities are either cooling joints or are originated from tectonism or are resulted from stress relief.

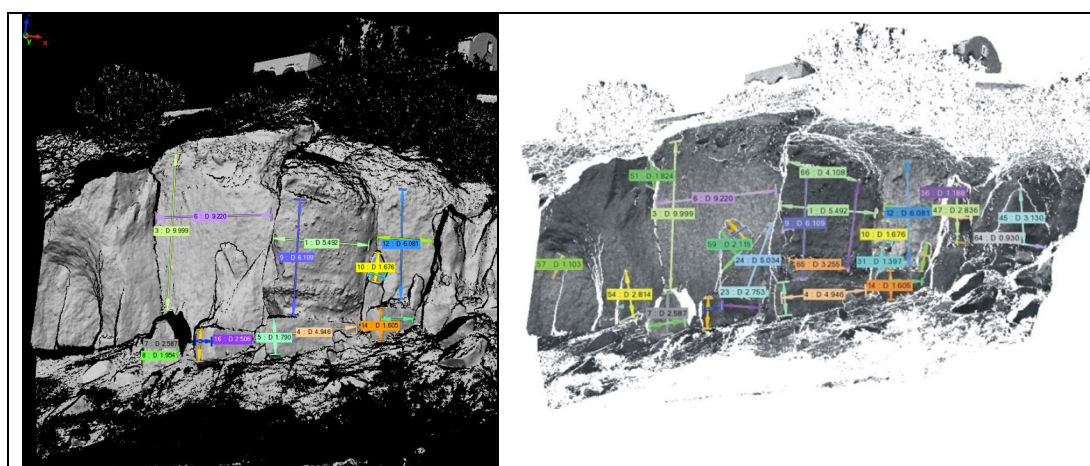
The process of the LiDar image of “Apothikes” location had as central axe the determination and measurement of the dimension of blocks. The software provides the possibility to measure the exact volume of a block instead of making assumptions and comparisons to basic shapes. Thereafter, we classified the thickness in order to determine the major class. It was found out that the maximum thickness of the pillars was 5 m and the 95% of blocks had thickness below 4 m. Therefore, for our analysis we used the value 4 m in order to make a realistic model (Figure 7).

Figure 7. LiDar image showing the estimation process of dimension of the unstable or fallen blocks (right).

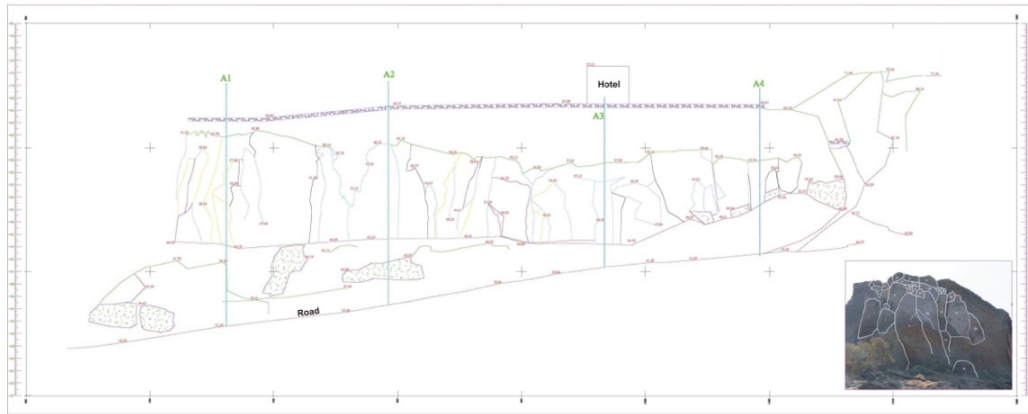
Having completed the alignment of the point clouds, a measuring of the dimensions of the unstable rocks was performed. The dimensions of the largest boulders are 10X9m (height X width) while smaller ones are also measured. A segmentation of the rock pillars that are likely to fail were mapped in order to assist the rock fall hazard assessment and the design of the remedial measures (Figure 8).

The hazard of new rock slides is very high, since several unstable rock blocks are present, either already moved or unloaded by recent instabilities. Indeed, instabilities have been recorded in the whole length of the road, several blocks are found along the beach, while wide open joints are present.

Figure 8. The façade depicting all the unstable blocks along the studied area.

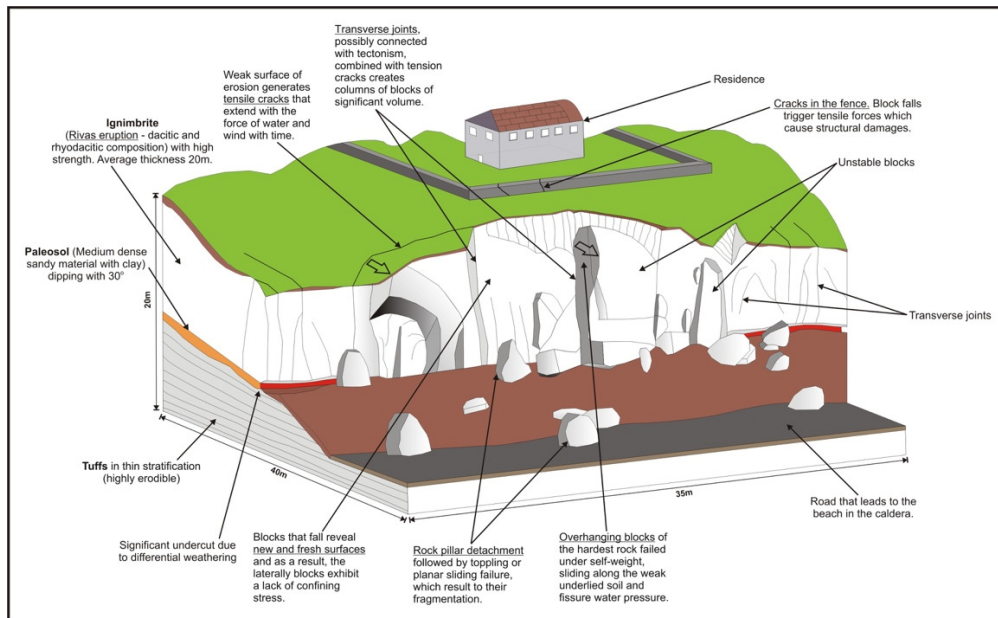
The main failure mode consists of rock pillar detachment followed by toppling or planar sliding failure, which result to their fragmentation. As the morphology is steep, blocks are likely to propagate downhill until sea level, passing three times over the local road and finally through the public beach. It has been concluded that the slopes are likely to collapse due to differential weathering. The differential erosion is caused along the contact of the hard ignimbrite and the looser paleosol. This weak surface of erosion generates tensile cracks that extend with the force of water and wind with time. Thus, erosion is then accelerated. These tension cracks combined with other transverse joints, possibly connected with tectonism, creates columns of blocks of significant volume. As an outcome overhanging blocks of the hardest rock failed under self-weight, sliding along the weak underlied soil and fissure water pressure. The blocks that fall reveal new and fresh surfaces and as a result, the laterally blocks exhibit a lack of confining stress. Therefore, new cracks begin to appear and the same process accelerates. An engineering geological conceptual model of the studied area is presented in Figure 9.

Figure 9. An engineering geological conceptual model of the studied area.

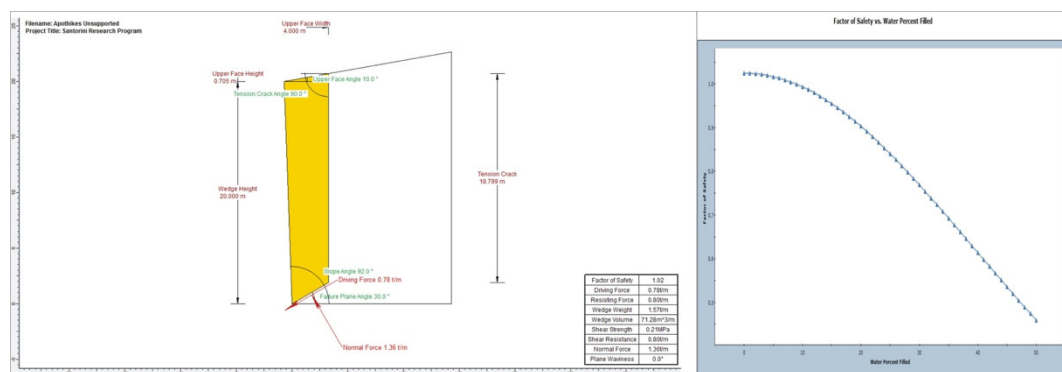
The model consists of a 20m height and slightly overhanging slope (92°). The planar surface was simulated with an exaggerated inclination of 30°, since sings of prior failures indicated that the critical plane passes through the weak underlying layer. Material properties were determined by field and laboratory tests, resulting to the equivalent Mohr-Coulomb parameters that were used for the analyses ($c=5\text{kPa}$ and $\phi=30^\circ$). Vertical discontinuities (persistent throughout the whole slope's height; therefore, filled with water) were simulated 4m behind the crest. In order to design the full face nailing pattern, static and pseudo-dynamic analyses were conducted for various water heights within the discontinuities.

Figure 10. Sliding analysis with RocPlane software from RockScience's suite shows that safety factor (F) is 1.02 (left). Diagram Factor of Safety-Water Percent Filled, shows that safety factor (F) drops below 1.0 with a small percentage of water (right).

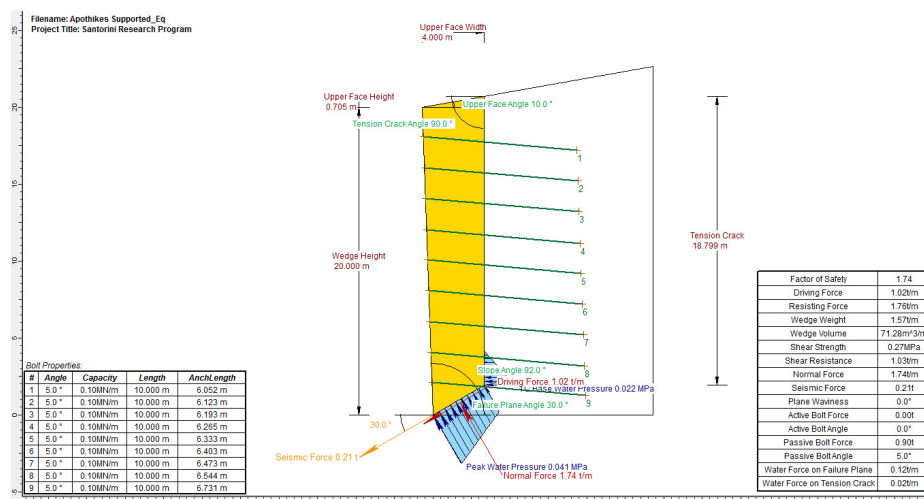
Figure 11. Sliding analysis with RocPlane software from RockScience's suite, after the implementation of the remedial measures.

In order to prevent failure and the accompanied consequences, various mitigation methods were examined based on the site's geological and geotechnical conditions, cost, local architecture restrictions and constructability. The principle of the proposed measures are: a. Extensive mechanical scaling in order to create a safe working environment and slope free of tension cracks; b. Nailing with fully bonded anchors ($d=25\text{mm}$, $l=10\text{m}$) on a 2x2 pattern and c. Steel nets, in case of local poor rockmass conditions, that will be anchored to the nails and lashed by transversal wire ropes.
