A SLOPE STABILITY CASE IN ARCADIA: Case Narrative

Highway on the move (EN) – Αυτοκινητόδρομος εν κινήσει (EL)

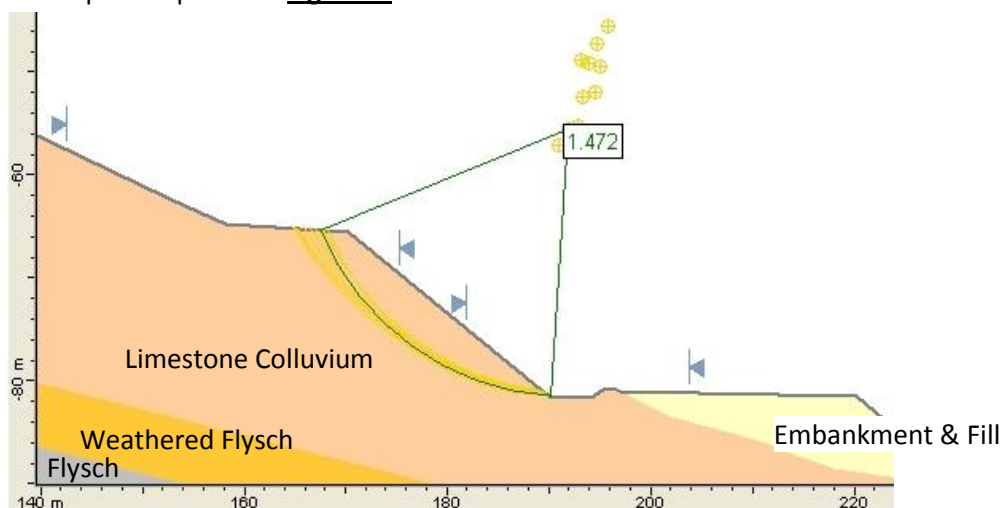
Figure 2: Critical failure surface of the cut slope, long-term conditions (Bishop method).

Calculations show that the cut slope has a factor of safety (FoS) of 1.472, the embankment slope has a factor of safety of 1.992, while the combined embankment/foundation material cross section has a factor of safety of 1.973. Respective values of FoS for dynamic loading are as follows: 1.197, 1.419 and 1.497 (note that the Greek regulations for seismic design stipulate higher seismic acceleration parameters for embankments compared to cut slopes). The critical failure surface for the case of the cut slope is depicted in **Figure 2**.

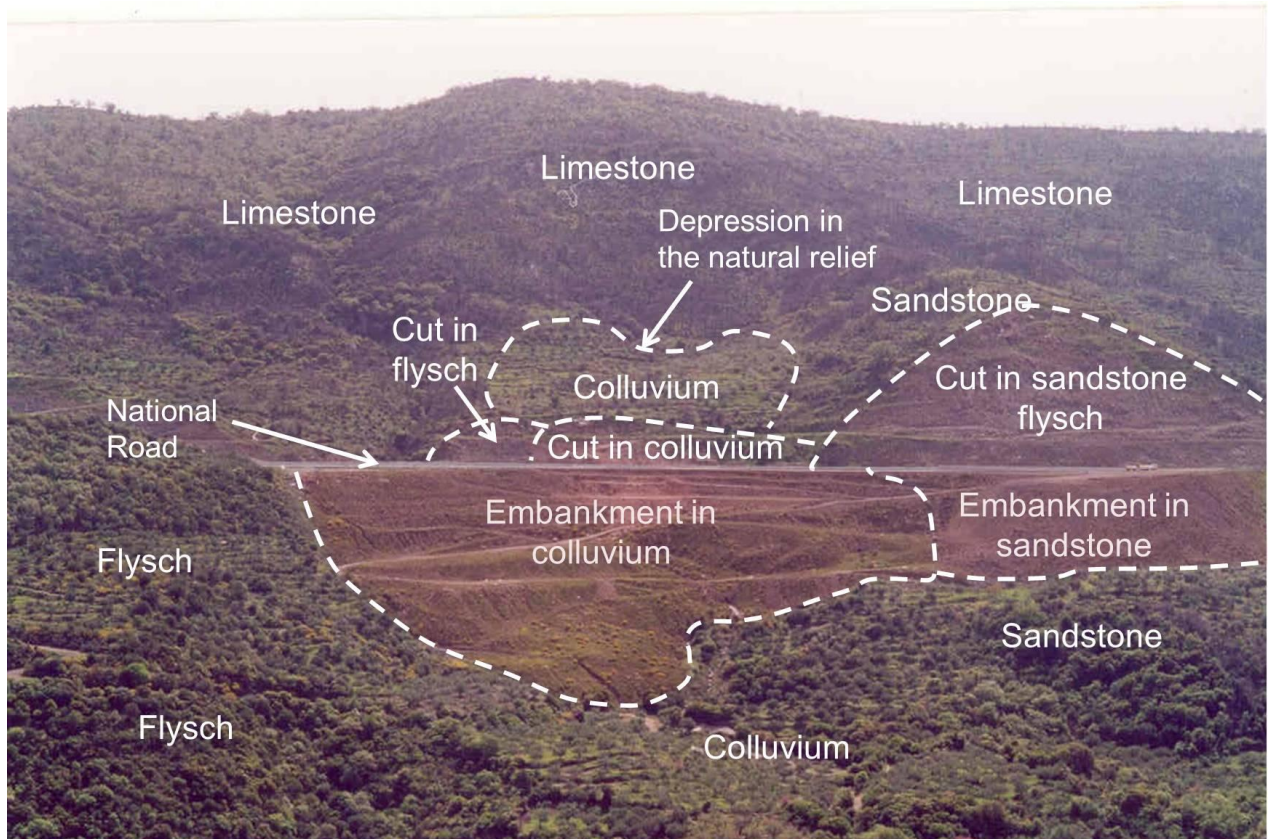
Since the calculated factors of safety are adequate, your supervisor decides to take your group for a site visit, where you have a chance to see the slope in real life (**Figure 3**). There, the group notices deposited material in addition to the area of the cross section you have checked. A geologist colleague points out for you some of the units you encountered in your calculations (see Figure 3). He also shows you a depression and below it a milder slope in the natural relief of the colluvium underneath the limestone, which could indicate a possible movement in the geological history of the slope.

Figure 3: View of construction area (adapted from Dounias et al., 2006).

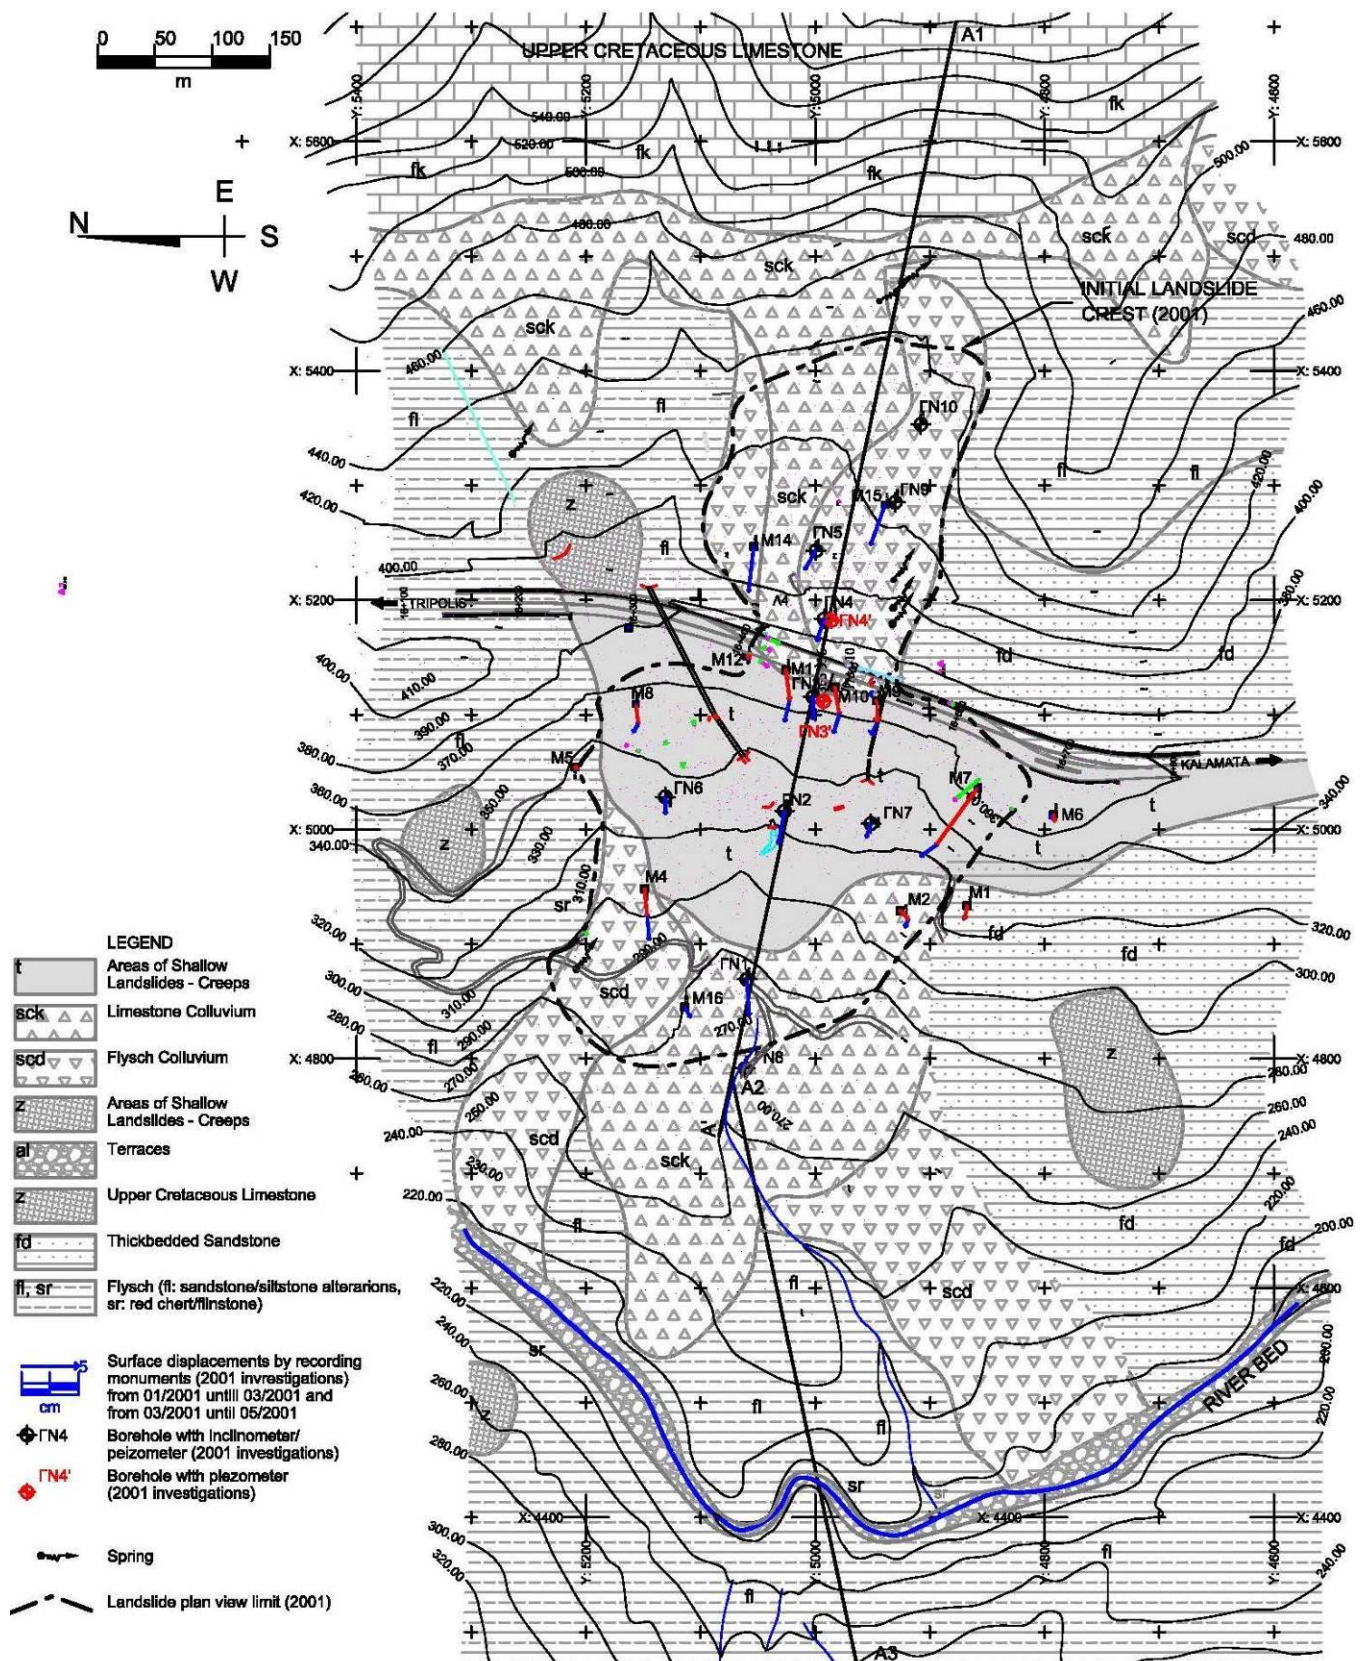
As cracks continued to get larger, albeit at a slow rate (Dounias et al., 2006), the ministry commissioned an in-depth site investigation, which included borehole sampling and logging, in situ and laboratory tests, and recordings of inclinometers, surface monuments and piezometers. The investigation was completed in 2001 and established the existence of a sliding surface 680m long and 200m wide at the highway axis, reaching a maximum width of 370m downslope of the highway (see **Figure 4**). As shown in **Figures 5 and 6**, the main part of the slip surface was located (on the basis of inclinometer readings) within the zone of the weathered flysch (sz), a clayey material of medium to low plasticity, at a variable depth of about 25 to 35m.

Figure 4: General plan view with the limits of the slip surface in 2001 and the horizontal surface displacements (adapted from Dounias et al., 2006).

Measurements obtained over a period of six months (November 2000-May 2001) gave an average displacement rate of 20cm/year, indicating an active but slow landslide [according to TRB (1996) slides moving at a rate of 1.6mm-1.6m/y are characterized as very slow], which necessitated the evaluation of alternative repair measures. Given the observed movement, the material was likely at a residual state within the slip surface.

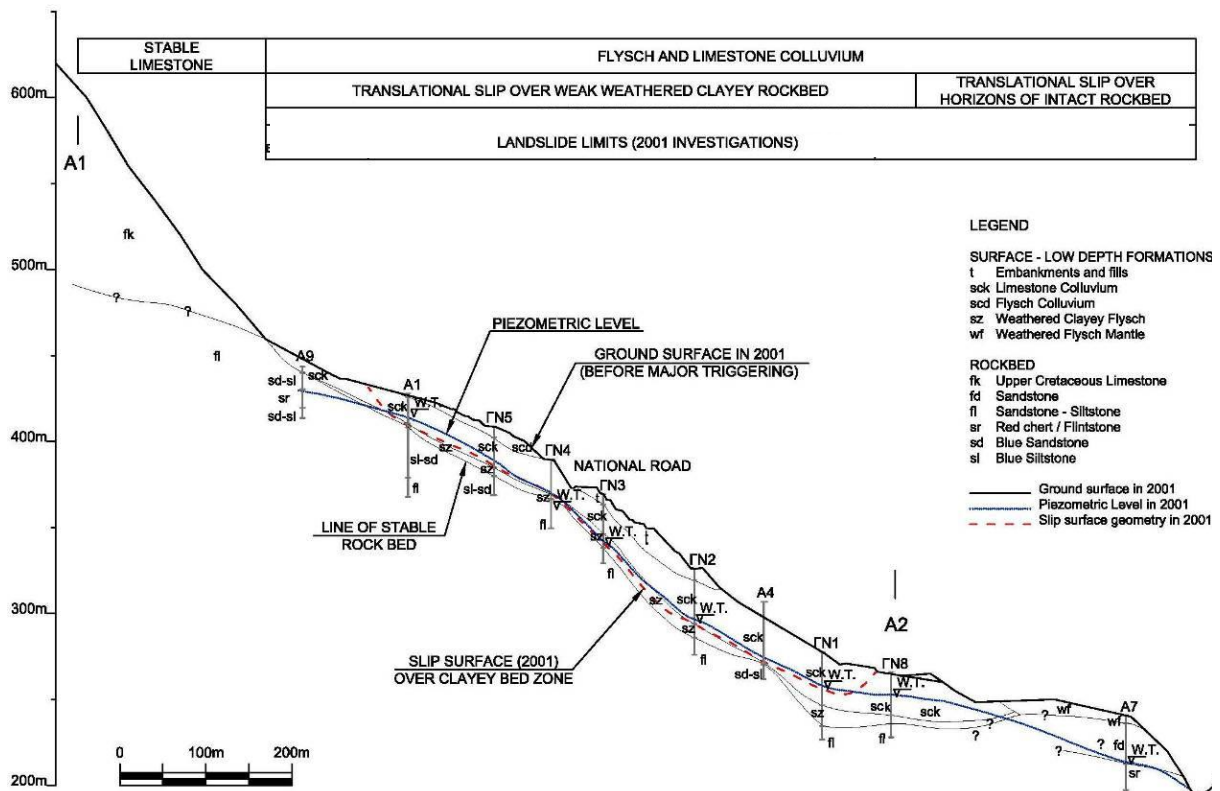
Figure 5: Cross section of the slip surface in 2001 along axis shown in Figure 4 (adapted from Dounias et al., 2006).

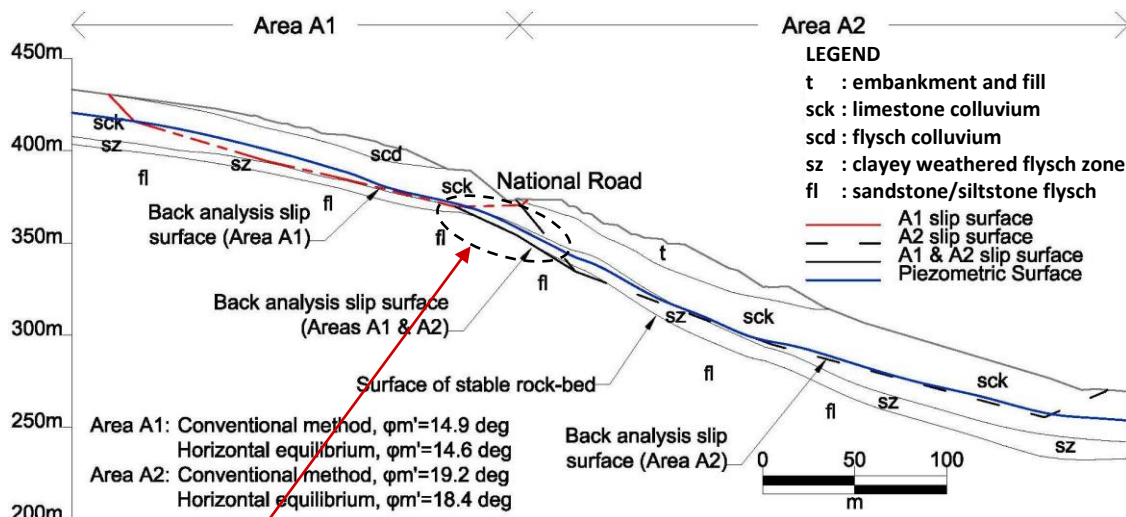
Back analyses are performed in order to evaluate the shear strength parameters along the slip surface. Due to the considerable displacement over the aforementioned 6-month period, back analysis for a $FoS=1$ is expected to give a value of average mobilized shear resistance that corresponds to the average residual strength of the material along the slip surface. Two alternative sliding mechanisms are considered: one single slip surface or two semi-independent slip surfaces, uphill and downhill of the highway, involving areas A1 and A2, respectively, as shown in **Figure 6**. The two-section slip surface is the kinematically plausible sliding mechanism suggested by the geometry of the surface of the flysch bedrock (see Figure 6). As this back analysis is more involved than the one corresponding to the cross section of Figure 1, you are not expected to perform it on your own. A senior geotechnical engineer discusses with you the analysis for A2 and you are asked to do the same for A1. In both cases, the geometry of the slip surface depicted in Figure 6 indicates a translational type of slide instead of a rotational (i.e. circular) one.

Figure 6: Cross section showing the two-part slip mechanism along the axis of the slip surface. The dashed-line oval shape highlights the hump in the curvature of the intact/weathered flysch that imposes a kinematic constraint on the failure mechanism.

The results from the back analysis of area A2 for FoS=1 give a mobilized angle of friction ϕ_m' equal to 19.2° and 18.4°, with methods A and B, respectively.

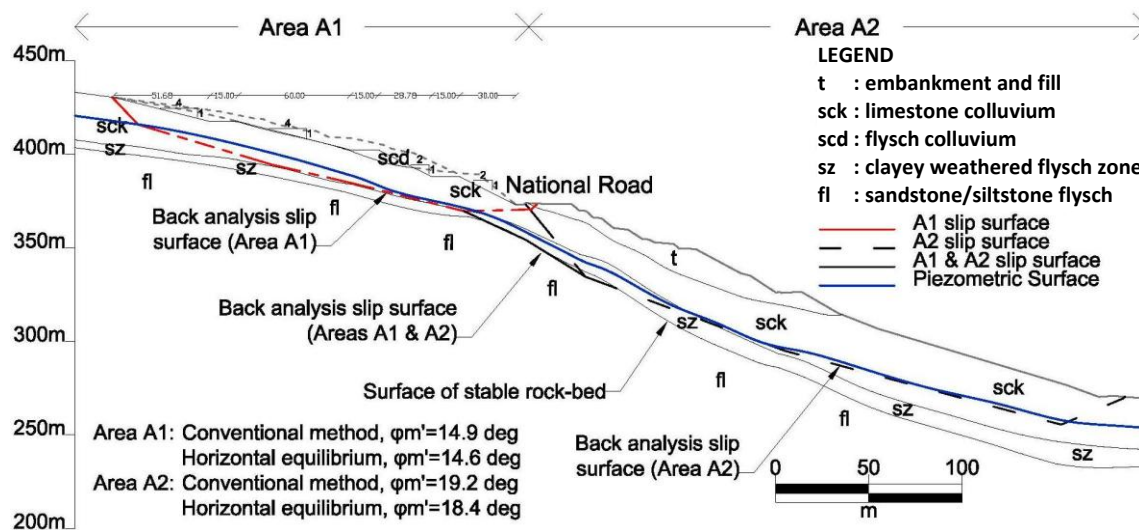
Your final task for the project is to help the senior geotechnical engineer of the team with the analysis for the repair option with excavation, for sliding area A1 (**Figure 7**). Excavation as a repair alternative, in general, aims to relieve the slope from some weight, mainly at the upper part of the sliding area, thereby increasing the overall stability (i.e. FoS) of the slope. In this case, however, the geometry resembles that of an infinite slope, for which FoS does not have a strong dependence on the thickness of the sliding mass. Nevertheless, since the average surface slope inclination and the inclination between berms in Figure 7 are milder than the inclination of the initial A1 area in Figure 6, the new geometry could be stable.

Figure 7: Cross section showing the excavation in area A1 evaluated as a possible remedial measure.

The calculated FoS assuming the piezometric level used in the back analyses is 0.961 and 0.973, for the conventional and the horizontal equilibrium methods, respectively. In other words, the slope is even more unstable after excavation! This unanticipated finding is likely a result of the reduced height of the sliding mass for the same piezometric level, i.e. of the higher percentage of saturated soil within the sliding mass. Hence, analyses were performed for only a small range of r_u values, in order to investigate the effect of further draining of the slope. The results are given in **Table 2** and

show that the slope is marginally stable even when fully drained ($r_u=0$) and, hence, excavation is not a viable repair alternative.

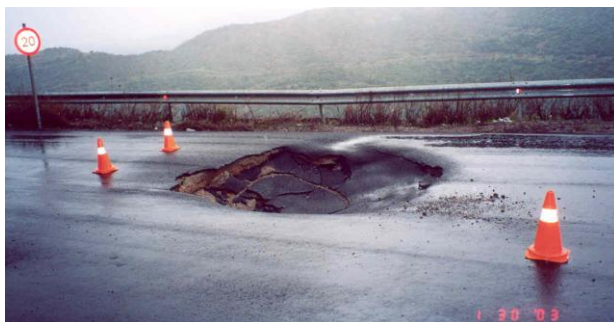
During the heavy-rain winter of 2003, the pavement suffered considerable settlement in January, which soon developed into a large pothole (**Figure 8**). Cracks were enlarged, and increased flow rates were recorded in the drainage system of the slope. In early February 2003, with rainfall continuing, a rapid movement of earth material took place, cutting through a 200m section of the highway. Movements continued over the next several days. When the sliding mass reached a resting position, the pavement had moved 100m horizontally and dropped 40m vertically (Fig. S.9 in the supporting material). The extent of the 2003 failure on the cross section is shown in Figs. S.4c and S.5b of the supporting material. The limits of the landslide extended further downslope to the riverbed (shown in Fig. 4), reaching approximately 1km length.

Figure 8: Large pothole at the problematic section of the highway (from Dounias et al., 2006).

Due to the large volume of the sliding mass, the repair alternatives were more costly and more uncertain than bypassing the unstable area altogether. Two such solutions were considered, a tunnel behind the unstable mass, going through the flysch stable bedrock and below the slip surface, and a bridge, with a span of 300 m to ensure the foundation of bridge piers on stable material. At the end, the bridge was selected as the most economical solution.
