Goliath Gantry Cranes

Their Steel Structure – A Neglected Element

Experiences in Surveillance and Reconditioning of the Last Two Decades

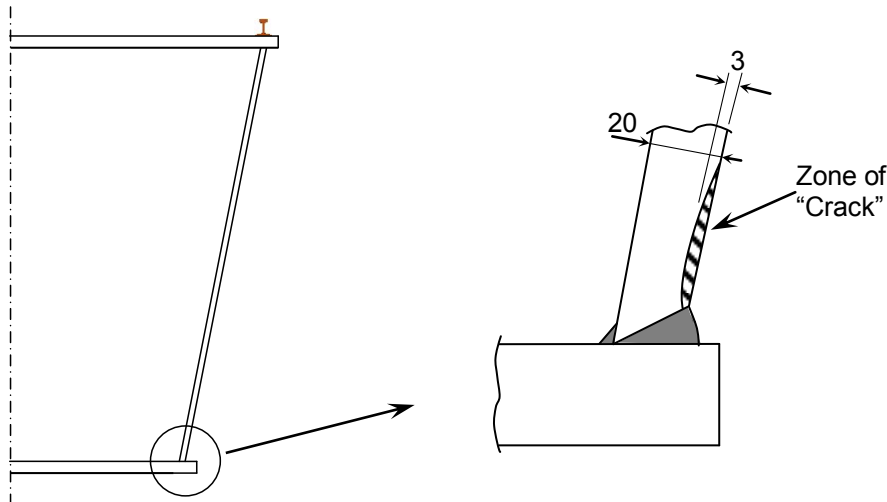
Figure 1: Material defects – Case 1.

This case refers to a defect discovered in the lower part of web of the main beam of a large gantry crane, near the joint with the bottom flange (see Figure 1). It existed at mid-span, extending for a length of approx. 600 mm and a height of 50 mm above the bottom flange. It was discovered by the Alternating Current Field Measurement (ACFM) method. First it had appearance of a crack, but after careful examination and grinding it was established that it was a “lap” in the plate, present since the origin that after the years became loose. Careful grinding of the area was carried out until the defect was eliminated. No re-welding was envisaged due to tensile stress permanently present in this area from the main beam own weight, reaching approximately 100 MPa.

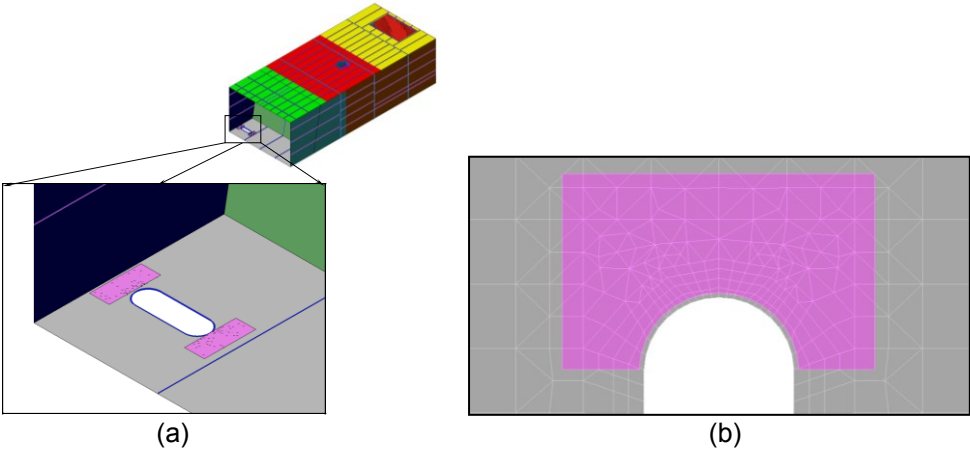
Figure 2: Design errors – Case 1.

The design problem in this case was a cable hole in the bottom flange of a cross beam of the crane, being oriented with its largest dimension perpendicular to the direction of principal tensile stresses developed in the plate (see Figure 2a, where half of the cross beam is shown for better illustration). This configuration resulted in a large stress concentration at the edges of the hole, which in time could have jeopardized structural integrity of the cross beam. The area was reinforced by putting friction-bolted doubler plates near the edges of

the cable hole. Various shapes were investigated by using finite elements, with the one shown in Figure 2b found to be the optimum one.

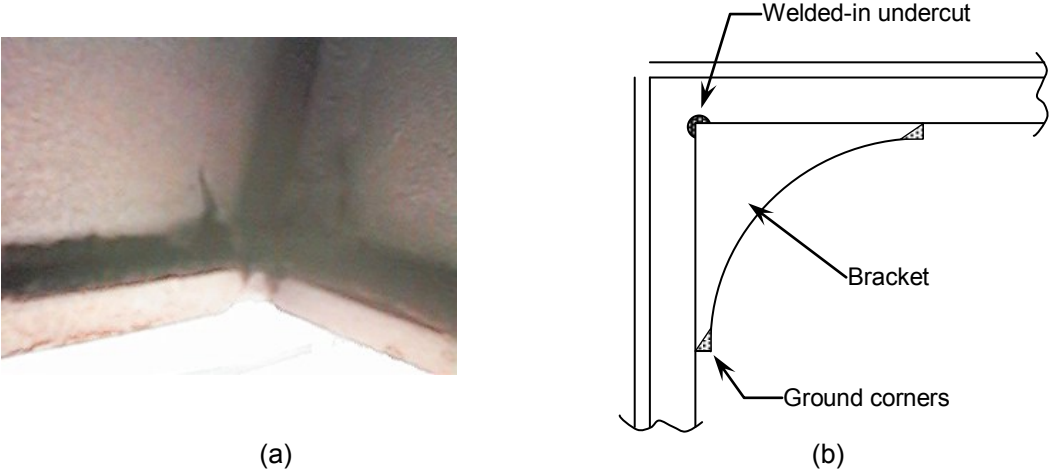
Figure 3: Design errors – Case 2.

The problem was the existence of an undercut in a junction of bottom flanges of two beams of a trolley (Figure 3a), both these flanges being loaded in tension. Repair works included filling of the undercut with weld and welding of an additional curved bracket, as shown in Figure 3b). The initial right-angle corners of the bracket were, after welding of bracket to the beams, ground smooth for optimum geometry.

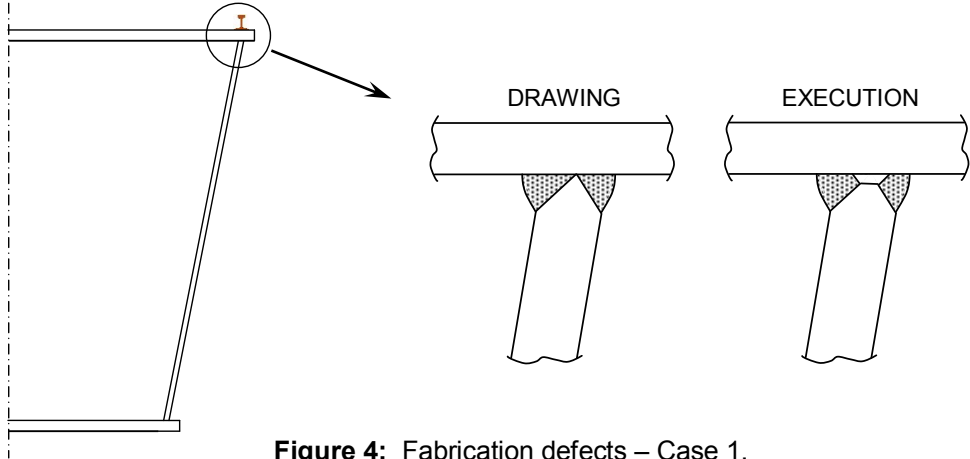
Figure 4: Fabrication defects – Case 1.

In this case, the problem concerned improper execution of throat weld between the top flange and the web of main beam of the crane, just below the trolley rail (Figure 4). Insufficient penetration of this welding resulted in development of a longitudinal crack in the weld extending for about 200 mm, discovered by the ACFM method. The crack was repaired

by careful removal and rewelding limited to the area where the crack was found. Although the problematic throat weld was extending along the whole length of the section involved (16 m), for practical reasons it was not possible to repair the whole weld. The yard was informed to pay specific attention to this area during future surveys.

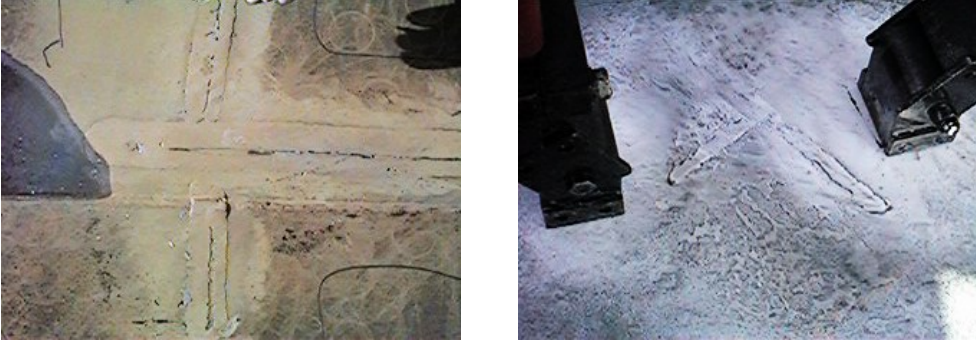
Figure 5: Fabrication defects – Case 2, two different examples.

In many cases, remnants of gussets and brackets used for fabrication and/or erection purposes were found like those shown in Figure 5 below. These remnants were traces of weld metal due to improper removal of these structural appendices leading to cracks in some cases. The cracks were discovered by grinding out these remnants and investigating the area with NDT techniques. Repair was limited to grinding out the cracks, since they were not deep.

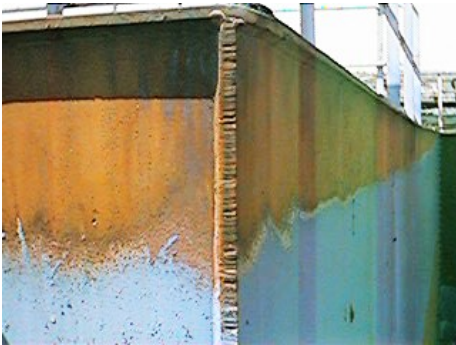
Figure 6: Fabrication defects – Case 3.

A common fabrication defect is poor quality of edge cutting of various free edge plates, like the one shown in Figure 6 of the cross beam web plating. These saw-tooth shaped edges are a perfect example of potential crack initiation points, when they are parallel to

main tensile stresses of the structure. The problem was resolved by grinding the edges smooth and checking with magnetic particles to verify that no micro-cracks remained behind.

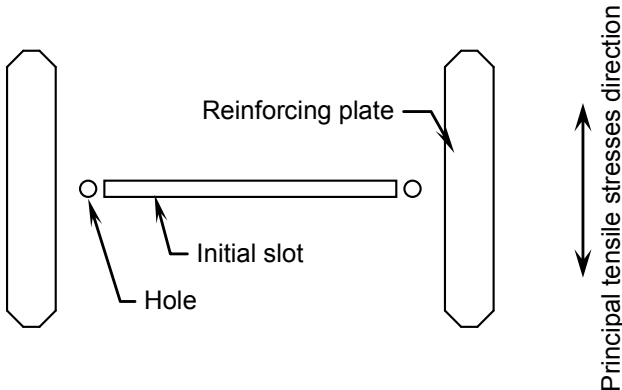
Figure 7: Erection defects – Case 1.

This case is about a situation on the main beam of a Goliath crane equipped with a bracket. In the area of maximum tensile stress of the beam top flange, lifting plates for erection purposes were introduced passing through the tension flange in a direction perpendicular to the principal stress (Figure 7). After erection these plates were cut off flush with the top surface of the flange. The erector, being aware of having done something incorrect, drilled a hole on each side of the slotted plate, introducing a bolt in each, spot-welded to the flange. In addition, a reinforcing plate was designed and welded to the flange on each side of the detail (Figure 7). The result was creation of cracks in the bolt holes, with much worse potential damage to be expected from such arrangement. Repair included removal of existing reinforcing plates and designing and installing friction-grip bolted doubler plates on both sides of the flange, around the critical area.

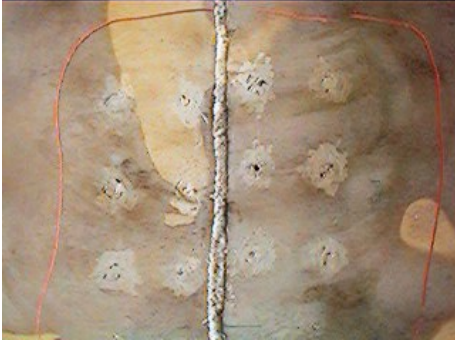
Figure 8: Erection defects – Case 2.

This example concerns bolt holes drilled initially to accommodate bolting of connection plates in order to join by welding sections of the crane beam. After assembly, these holes

were normally filled in by welding. In several cases, this welding was done improperly resulting in formation of defects like those shown in Figure 8, leading to severe stress concentrations. These defects were visually discovered after removal of paint. Initial attempt to re-weld the holes with preheat led to formation of cracks. This fact indicated that the parent material was very brittle, indicating execution of the initial fill-in welds at a low temperature and without preheat. Final solution was to re-drill the holes, preheat and re-weld.

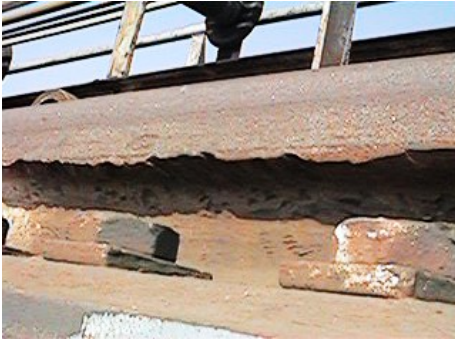
Figure 9: Erection defects – Case 3.

This case refers to the damage done to the service crane rails in order to fit the power tool socket on the bolt head to torque up the bolts. The bottom of the rail head was oxy-cut to make more space for the socket, as can be seen in Figure 9. No corrective measures were taken in this case, as the damage was characterized as irreparable. It has to be noted that these rails, friction-grip bolted to the main beam (hence part of the cross-section) are located in a zone of maximum tensile stress of the top flange, due to bracket action mentioned in paragraph 4.7.

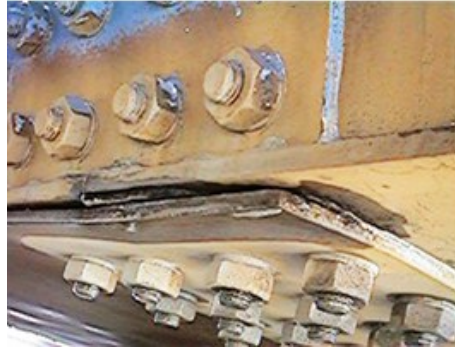
Figure 10: Corrosion – Case 1.

As shown in Figure 10, extensive corrosion was discovered at a friction-grip bolted joint of the main beam, due to insufficient attention paid to the water tightness of this joint. Corrective measures consisted of removal of rust as much as possible and sealing the joint.

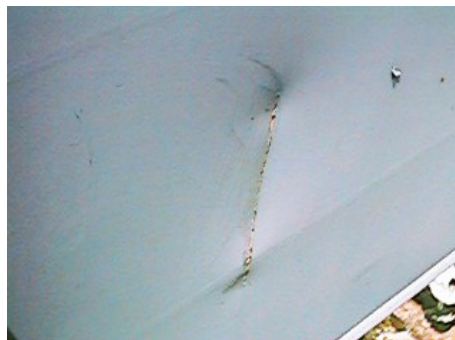
Figure 11: Operational damage – Case 1.

This example involves damage to one of the main beam webs near the counterweight area, due to collision with another crane (Figure 11). Compressive strength of the web plating has been substantially reduced by this damage. Repair was done by reinforcing local stability of the structure by installing additional stiffeners inside.

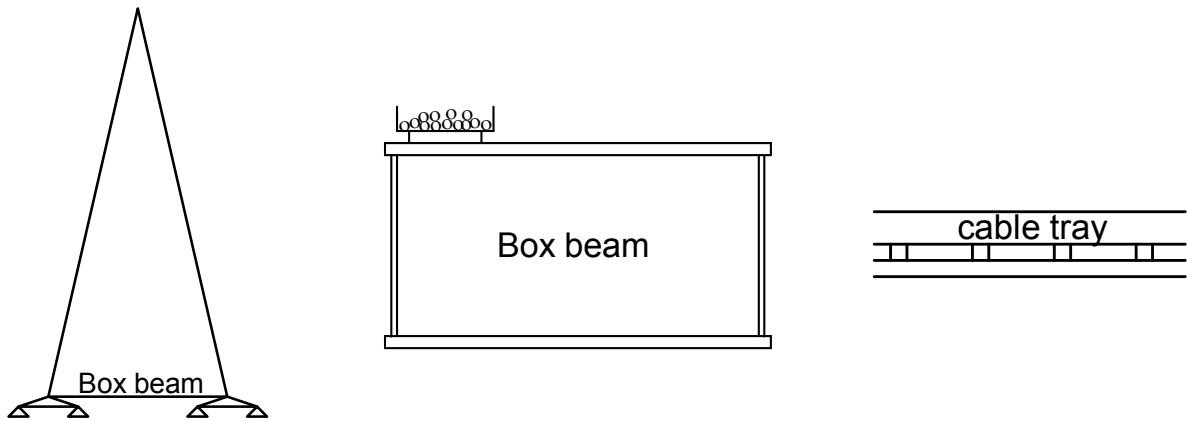
Figure 12: “Ghost” items – Case 3.

This example refers to the lower horizontal box girder of a triangular shear leg of a crane (Figure 12). The box girder had an approximate width of 800 mm and a height of 600 mm and was of the fully seal-welded type, e.g. there was no access into the interior. A cable tray was running on top of this box girder, sitting on “buckles” welded to the top flange. These buckles were so low (30 mm) that it was impossible to look properly under the tray.

The first indication was that the zone under the cable tray was heavily corroded. After removal of the cable tray and cleaning of the rust underneath, five small holes were discovered with a diameter of approx. 6 to 8 mm in the zone under the tray, in a rather concentrated area. A wire test established that they were going through the thickness of the flange. These holes must have been drilled before installation of the tray, which, evidently, was never removed before.

Result of these holes was water penetration inside the box beam, a fact that remained unknown for 30 years. The beam had no protective coating on the inside and, in consequence, heavy corrosion has formed. The box beam was opened on the side and about 50 buckets of rust mud were removed. The thickness reduction of the plates was about 50% in the bottom flange, 30% in the webs and 20% in the top flange. The only

favorable issue was that the holes were very small, their diameter further reduced by rust. As a result, water and oxygen penetration remained restricted.

In order to fix the problem of the box beam under permanent tension, it was recommended to use reinforcing strips in the areas affected.
