### Beyond the boundaries of feasible engineering geological solutions: stability considerations of the spectacular Red Beach cliffs on Santorini Island, Greece

V. Marinos<sup>1</sup> · G. Prountzopoulos<sup>2</sup> · P. Asteriou<sup>3</sup> · G. Papathanassiou<sup>1</sup> · T. Kaklis<sup>1</sup> · G. Pantazis<sup>4</sup> · E. Lambrou<sup>4</sup> · N. Grendas<sup>1</sup> · E. Karantanellis<sup>1</sup> · S. Pavlides<sup>1</sup>

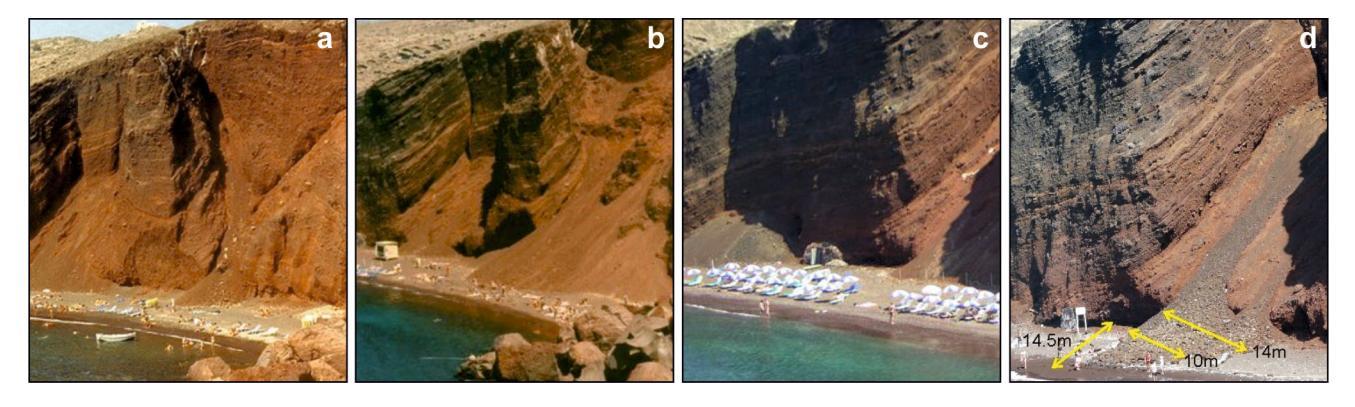
Fig. 3 Older rock falls along the Red Beach cliffs. A very large rockfall can be observed in  $\mathbf{a}$  (before) and  $\mathbf{b}$  (after) in the central part of the beach (zone K4, see Fig. 1). The fallen disintegrated mass

covered nearly half of the beach. Other older images c and d with similar rockfall mechanisms are observed at other locations along the beach. In such cases, the material covered only part of the beach

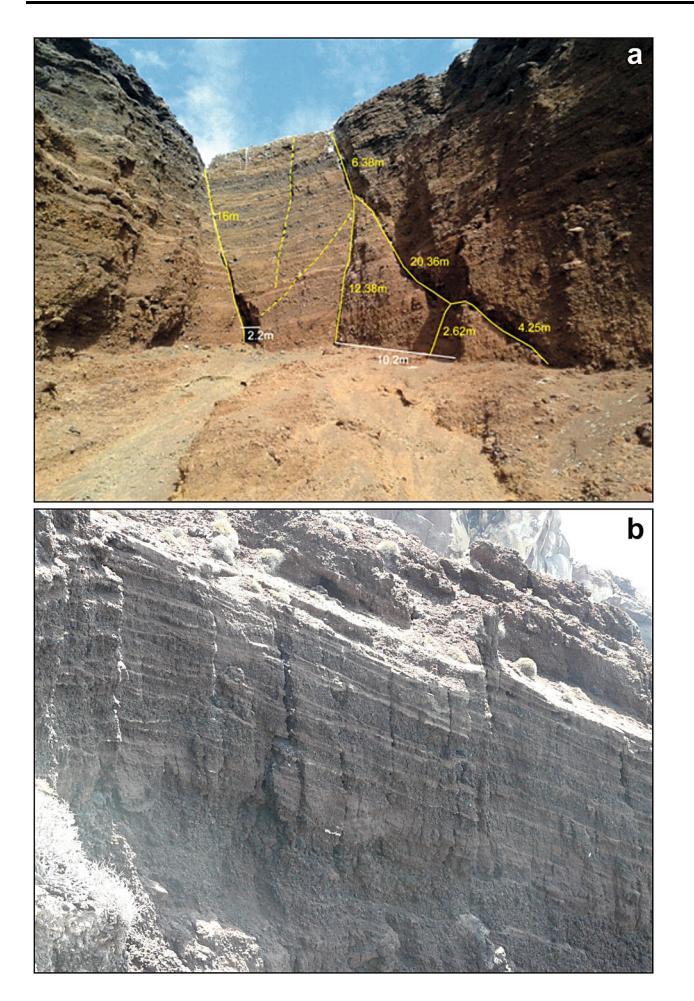
Fig. 4 Two-colored rock masses of scoria (red Sr in **a** and black Sb in **b**) that are clearly characterized by bedding-type surfaces daylighting in the slope face, which allow the possibility for the development of planar sliding failures if their strengths are low enough. Red scoria (**a**) is generally medium- to well-cemented and black scoria well to very well cemented (**b**). The friable nature of the rock along with multiple tensile cracks, which have been widened due to erosion, are evident. The toppling of rock block, due to vertical tensile and other joints, is the most frequent and episodic failure mechanism along the rock cliffs (**b**)

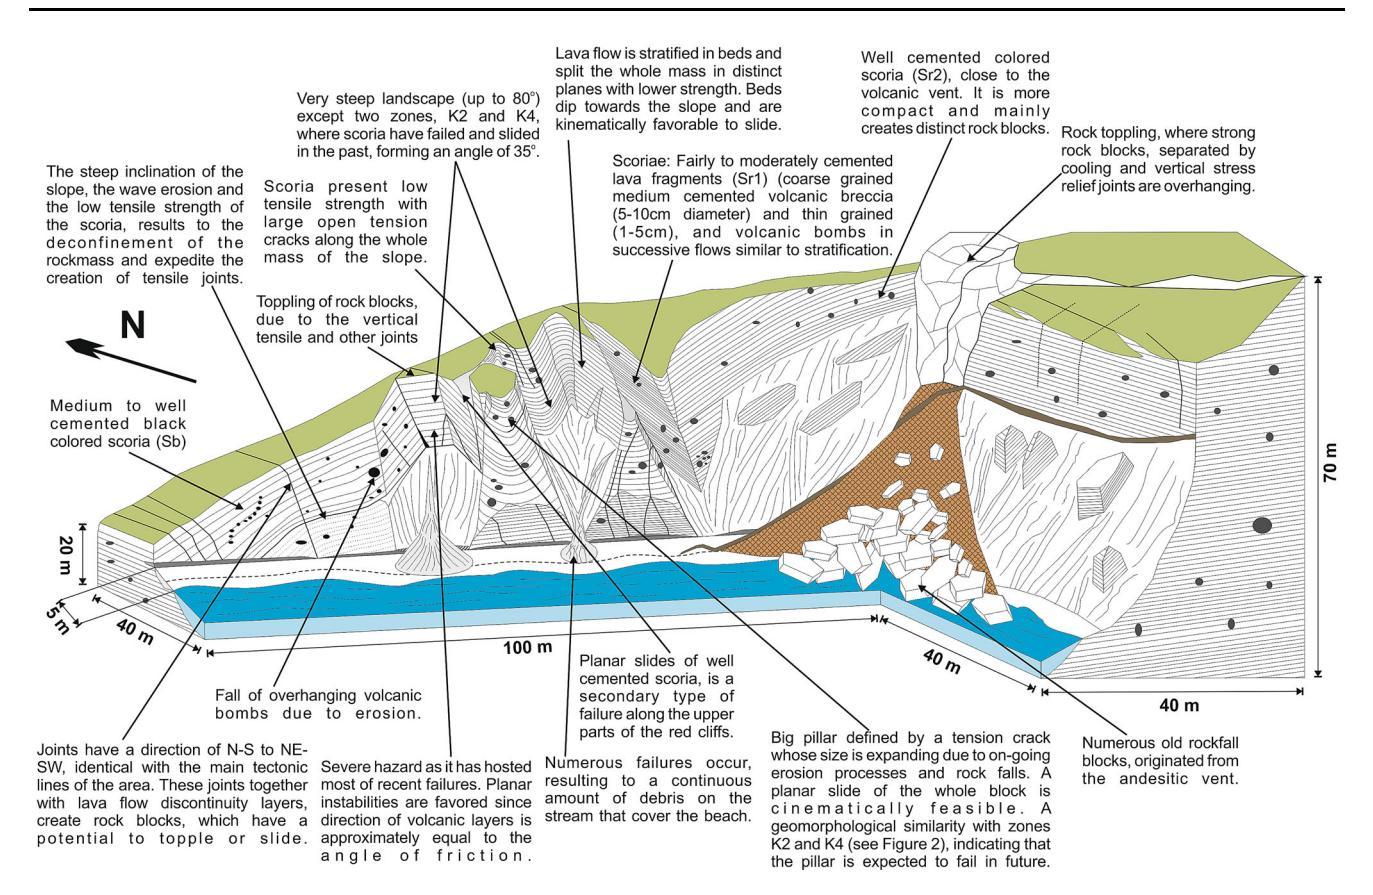
Fig. 6 Conceptual model of the geotechnical engineering conditions and rockfall phenomena along the Red Beach cliffs that was developed for the purposes of this study and is based on data provided by the results of field surveying and LiDAR scanning

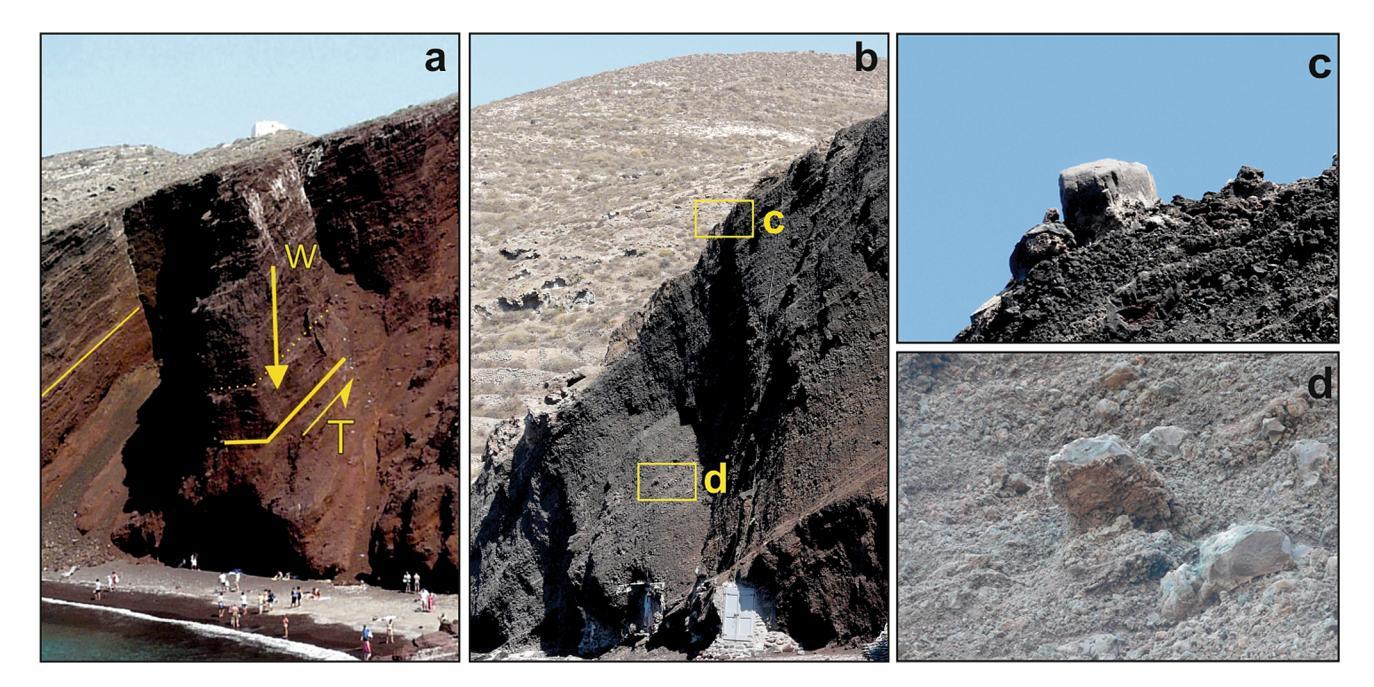
Additionally, planar sliding of well-cemented scoria represents a secondary type of failure along the upper parts of the red cliffs since the planes of the volcanic material daylight with regard to the slope face and have low strength along the planes (Fig. 7a). Relief joints that are vertical to the lava flows favor sliding failure since smaller blocks are consequently formed, while water pressure and erosion are enhanced.

Another mechanism involves the fall of small- to mediumsized volcanic bombs that are overhanging without support due to differential erosion and wave undermining. Such bombs are present throughout the whole slope area (Fig. 7b), and thus, falling hazards are very high. These cobbles can immediately create great danger to the public, especially in zones K1 and K3, where the cliffs are almost vertical.

**Fig. 7** Planar slides of scoria are one of the failure mechanisms since the planes of the volcanic material daylight with regard to the slope face and have low strength along the planes (**a**). The fall of volcanic

bombs that are overhanging without support due to differential erosion, which poses great danger to tourists, especially in zones K1 and K3 where the cliffs are almost vertical (b-d)

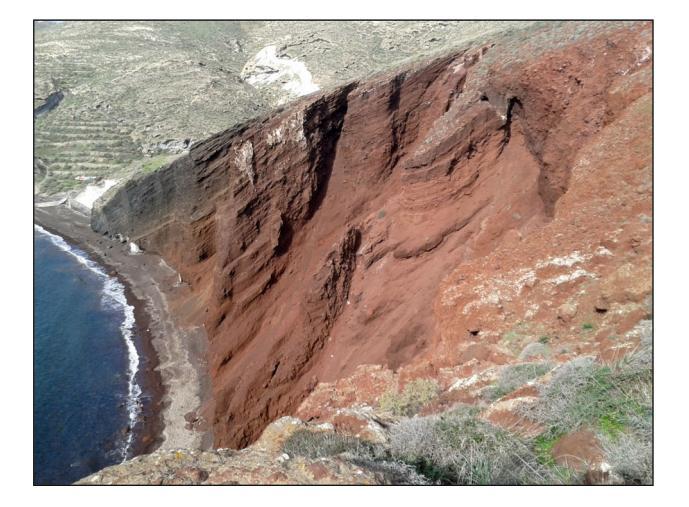
The slopes are substantially prone to environmentally controlled failures, which are attributed to weathering and erosional processes. As a result, the toe of the slope is slightly overhanging at a height of approximately 2–4 m, indicating that a main causing factor is erosion of the adjacent sea (Fig. 8). In addition, progressive erosion causes the raveling and release of rounded cobbles from their matrix, which then fall due to gravity. Rainfall, wind and seismic forces enhance these erosional and weathering processes.

**Fig. 8** Slopes that are prone to environmentally controlled failure, which is attributed to erosional and weathering processes caused by wave-based erosion and the low tensile strength of scoria. This deconfinement of a rock mass leads to the formation of tension cracks and consequently, the toppling of rock blocks. These characteristics do not favor the creation of specific unstable rock blocks that can be supported. The sizes of the unstable blocks are likely to exceed 10 m, making it possible for them to overcome a rockfall barrier. As shown in the figures, there is a high rockfall hazard during the construction and positioning of rockfall barriers, and the removal of these blocks is likely to disturb the stability of adjacent side slopes

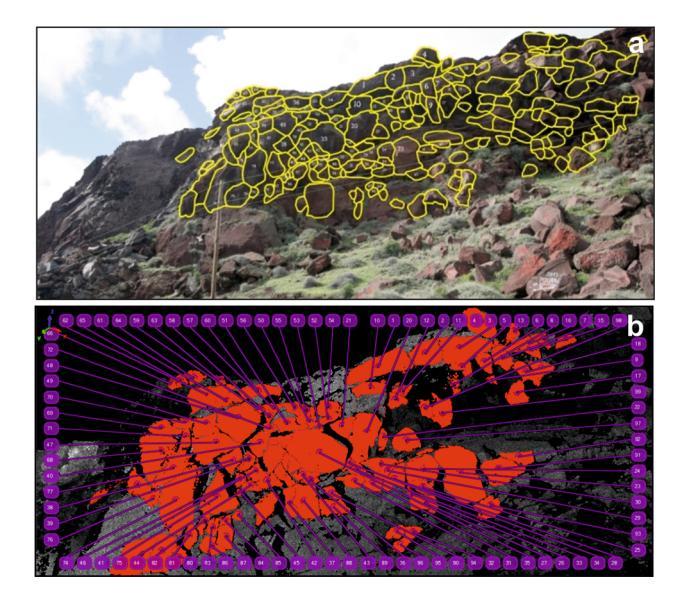
Fig. 10 Identification of volcanic rock blocks and their geometries using terrestrial laser scanning (LiDAR). Such an evaluation is clearer in the volcanic vent due to the compact-blocky nature of the geomaterial

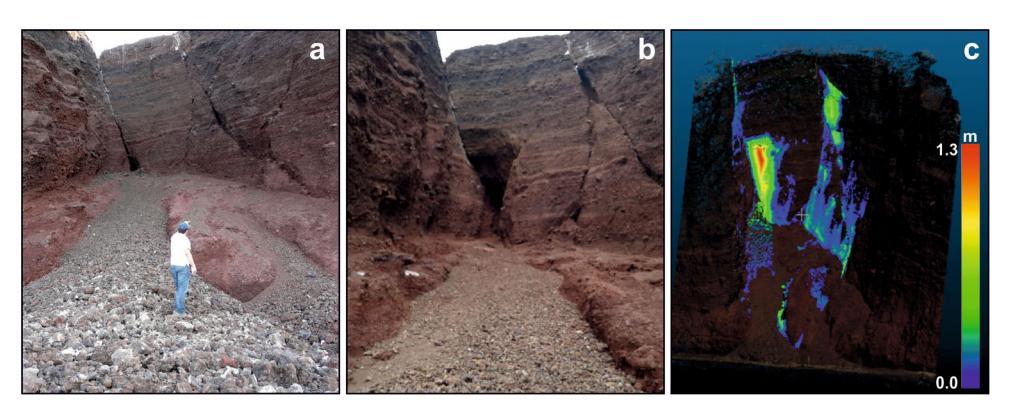
comparison of the total area of the Red Beach. Then, a more detailed quantitative analysis was conducted on the resulting areas of interest to extract the absolute values of the differences in the earth movements. The LiDAR and UAV point clouds were first aligned manually and then automatically. In the end, statistical metrics were performed on each alignment to evaluate the results. The RMS (root-mean-square) did not exceed a value of 0.5, which indicates an accurate and precise alignment result. Some of these movements and rock falls within this timeframe can even be observed macroscopically in zone K2 (Fig. 11). However, in addition, it became obvious during the 2017 visit that a concave area existed within the slope that was later validated from a comparison between the UAV and LiDAR data. The difference in the displacement of the material during this period reached a value of 1.3 m. Other rock falls and movements were also identified by this process in zones K1 and K4 (Fig. 12).

Fig. 12 An overview of the instabilities along the Red Beach cliffs between two field visits in 2013 and 2017 based on a comparison between the UAV and LiDAR data. Movements from rock falls and/or erosion are mainly identified in zones K1, K2 and K4 and are illustrated here in *red*

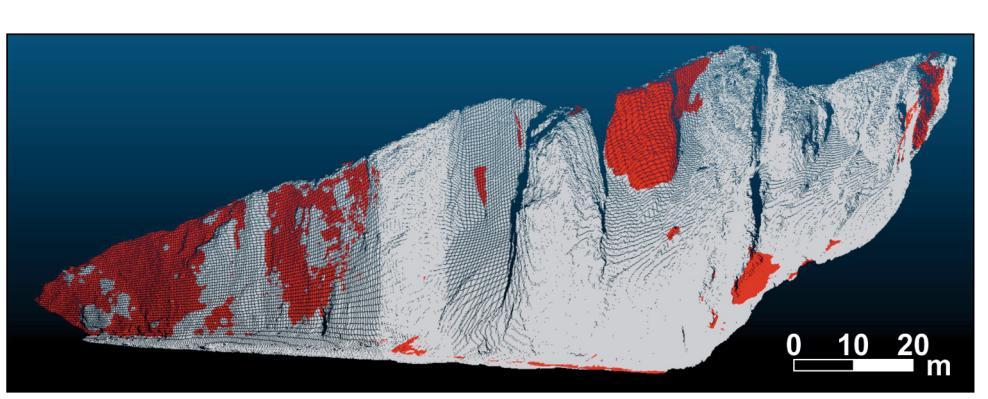
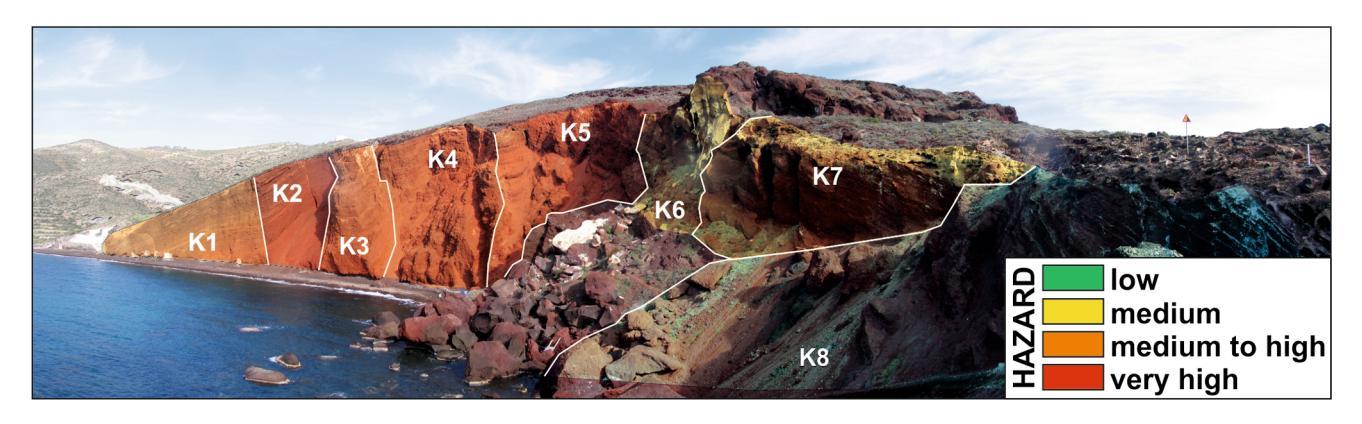
In zone 1, the potential is regarded as medium to high since various failures have occurred with discrete masses of significant size. Currently, many masses are apparent along the slope where instability is visually observable, mostly toppling to be released from the NE–SW tension cracks. Additionally, plenty of cobbles are visible on the slopes surface.

Fig. 13 Rockfall potential zoning along the Red Beach cliffs based on the history of older rock falls, the rock mass quality (i.e., volcanic rock type, structure and cementation), the height and steepness of the slope and the presence of unstable blocks

overhanging, and many cobbles are present. Plane instabilities are favored since the bedding angle is approximately equal to the angle of friction (i.e.,  $35^{\circ}$ ), and thus, the shear strength and dip direction of the bedding is collinear to the dip direction of the slope.

Zone 3 also presents very high potential. The slope toe is slightly overhanging, and many cobbles are present. To date, raveling has been the most common failure type, with few planar slides and toppling failures of limited size. However, the whole sector forms a large pillar (approx. 36 m in height) with almost vertical discrete surfaces. The rear surface is defined by a tension crack with a size that is expanding due to ongoing weathering and erosion processes. A planar slide of the whole block is cinematically feasible along the planes of the volcanic layers. Moreover, the zone is geomorphological similar to sectors 2 and 4, indicating that the pillar is expected to fail in future.

Zone 4 forms a cove wherein all of the materials originating from failures are concentrated within a main stream that ends a few meters above the beach level. Depending on the magnitude of the failure, its products might either temporarily accumulate and come to rest on the slope or be directly discharged onto the beach. The rock material is friable enough to cause raveling, while additional discontinuity sets favor the onset of both planar sliding and toppling. Additionally, when it transpires, surface runoff is intense due to the morphology. Therefore, numerous failures occur, resulting in a continuous amount of debris within the stream. Usually, these materials are slowly discharged, but if a failure of significant size occurs, a substantial amount of materials will rapidly spread out over the beach. Hence, the potential in zone 4 is assigned as high to very high.

Zone 5 presents medium to high potential. This zone is similar to zone 4, although the bay is significantly wider here. The slope is close to vertical and is absent any main discontinuity sets, and therefore, raveling is the most possible failure mechanism in this zone. Additionally, some cobbles are present, particularly in the middle of the slope where all loose scoria have already been detached. A major stream is apparent on the slope surface and forms the downward path of the debris. However, their flow can be easily controlled.

Zone 6 mostly affects the path leading to the Red Beach. The potential within this zone is assigned as medium. At the top, the slope is overhanging, the rock masses are dense and the joints exhibit a significant aperture, all of which permit both planar sliding and toppling. The beach is already covered by large blocks that have fallen in the past, denoting that a potential future failure will affect access to the beach. Additionally, some large blocks are scattered along the slope surface, whose motion could be triggered either by an earthquake or by heavy rain.

Zone 7 presents medium potential and consists of wellcemented scoria that form a uniform matrix. The slope is likely to have been formed after the failure of a dense rock mass, whose debris appears on the slope toe, since a failure surface is present. Only the toppling of few small blocks from the crest is feasible, but since the slopes above the path are relatively gentle and shallow, the likelihood of such a failure is minor.

Zone 8 presents low potential. The slope is steep near the crest where some relatively small blocks can slide or topple. However, the toe consists of loose scoria, which can act as a buffer and allow the blocks to come to rest.
