EDPs for damage accumulation in URM buildings and RC columns

Pablo Alfonso Garcia de Quevedo Iñarritu
Nevena Šipčić

49th Risk, Hazard and Uncertainty Workshop in Hydra, Greece

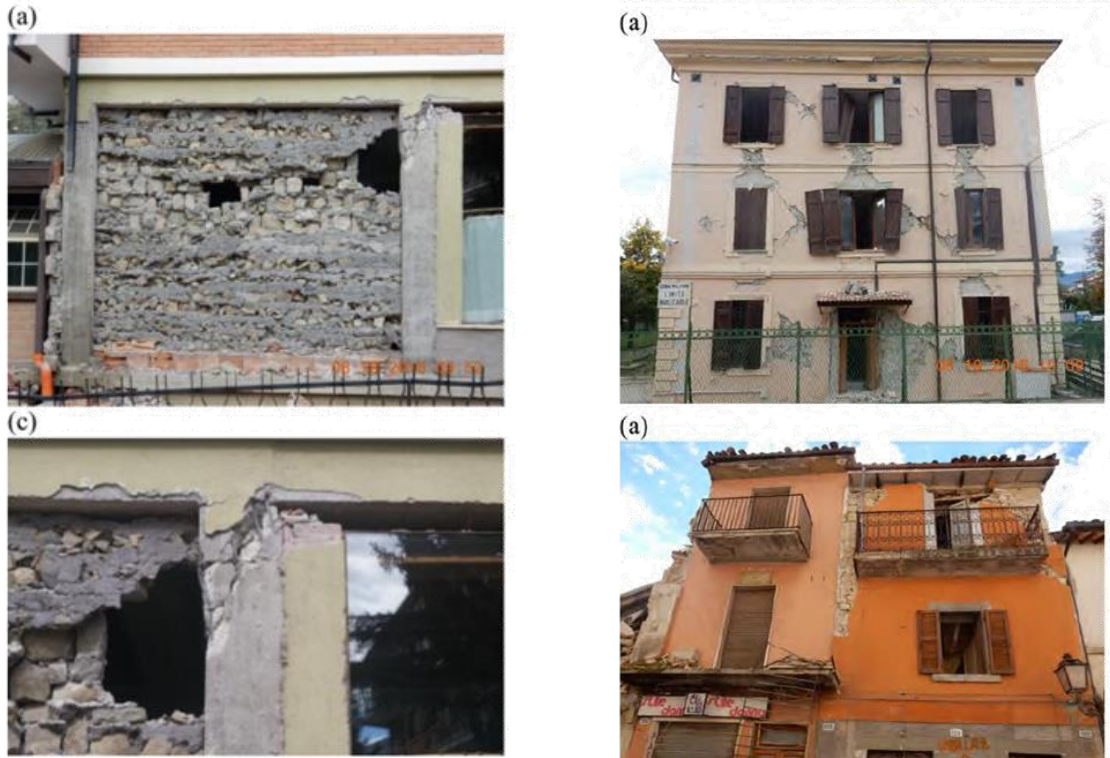
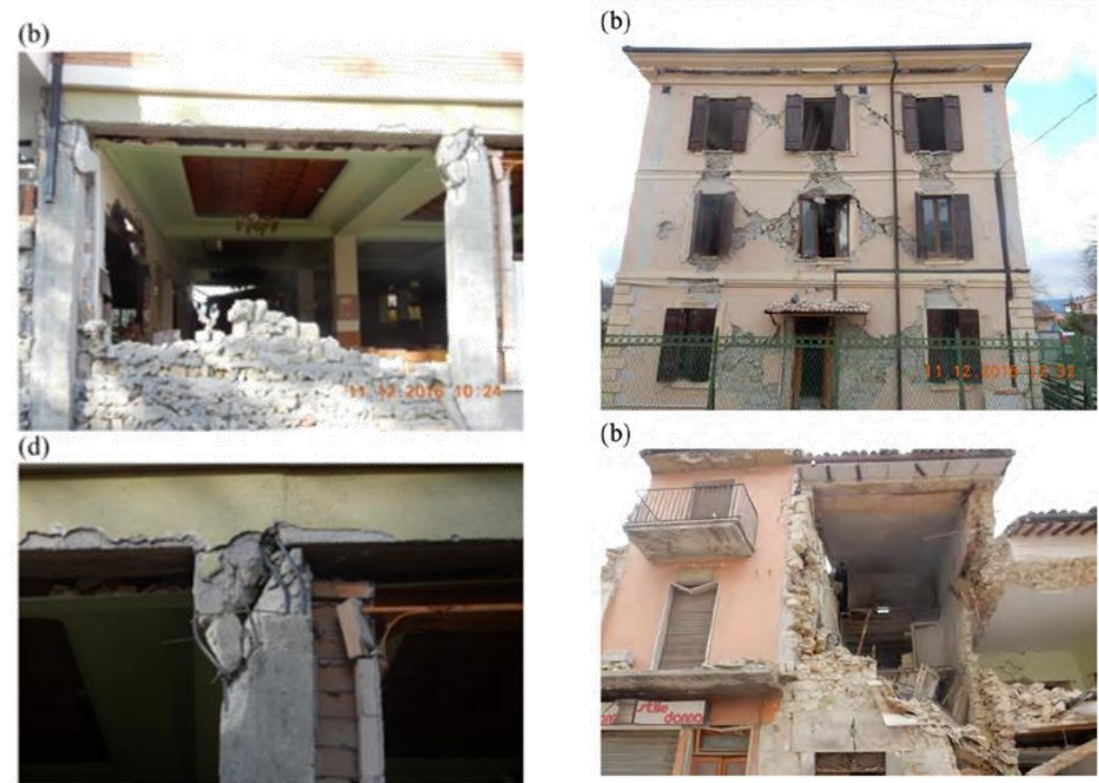
- Several seismic sequences proved that already damaged buildings are more vulnerable due to the damage accumulation. However, traditionally, pristine conditions are assumed!

After mainshock

After entire sequence

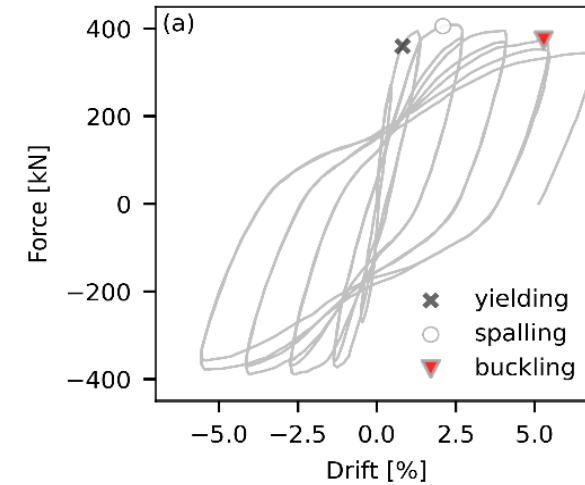
DI values corresponding to different damage states

- Using the experiments where detailed description of damage is provided damage states are proposed

FC	Median value	16 th - 84 th percentile	Proposed range	Description of damage
DS1	–	–	0 – 0.2	Flexural and longitudinal cracking, yielding of steel bars in tension, followed by shear cracking
DS2	0.17	0.13-0.25	0.2 – 0.4	The onset of concrete spalling exposing the transverse reinforcement
DS3	0.38	0.3-0.50	0.4 – 0.75	More significant spalling of concrete, longitudinal steel is exposed, the potential start of tie yielding
DS4	0.91	0.76-0.98	> 0.75	Major safety implications, bar buckling, concrete core crushing, fracture of the bars, complete failure

Median value	16 th - 84 th percentile	Proposed range	Description of damage
DS1	–	–	0 – 0.25	Flexure-shear cracking, formation of splitting cracks
DS2	0.27	0.15-0.4	0.25 – 0.45	Widening and localization of the shear cracks, onset of concrete spalling;
DS3	0.73	0.45-0.90	>0.45	Longitudinal bar buckling yielding of transverse reinforcement, crushing of the concrete core, axial failure;

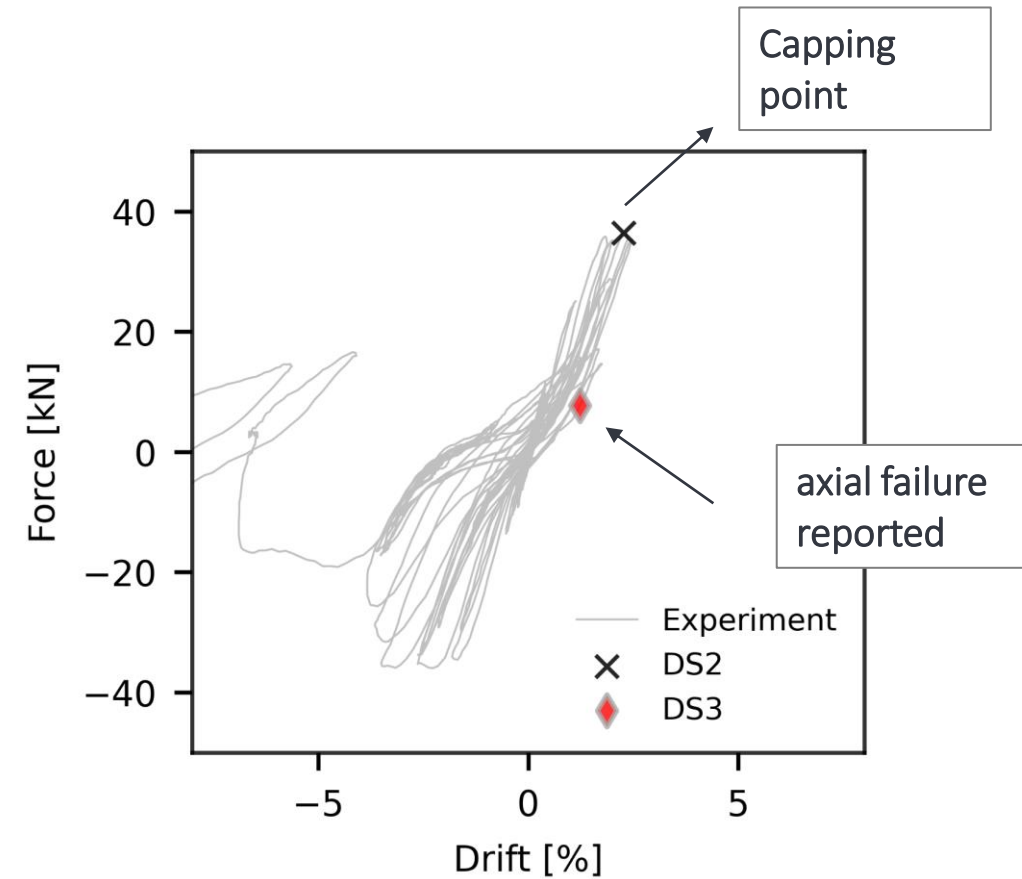
- Shake-table tests validation is a critical step within the proposed methodology as there is limited amount of data with the detailed description of damage thorough the experiment
- Additionally, we need to know the time step at which certain damage occurred to be able to find the corresponding dissipated energy
- All of the shake table tests that we gathered pertain to the flexure-shear-critical columns (23 tests in total)
- Example – test from Shin (2005)
 - $DI_2 = 0.35 (0.1+0.25)$
 - $DI_3 = 0.85 (0.3+0.55)$

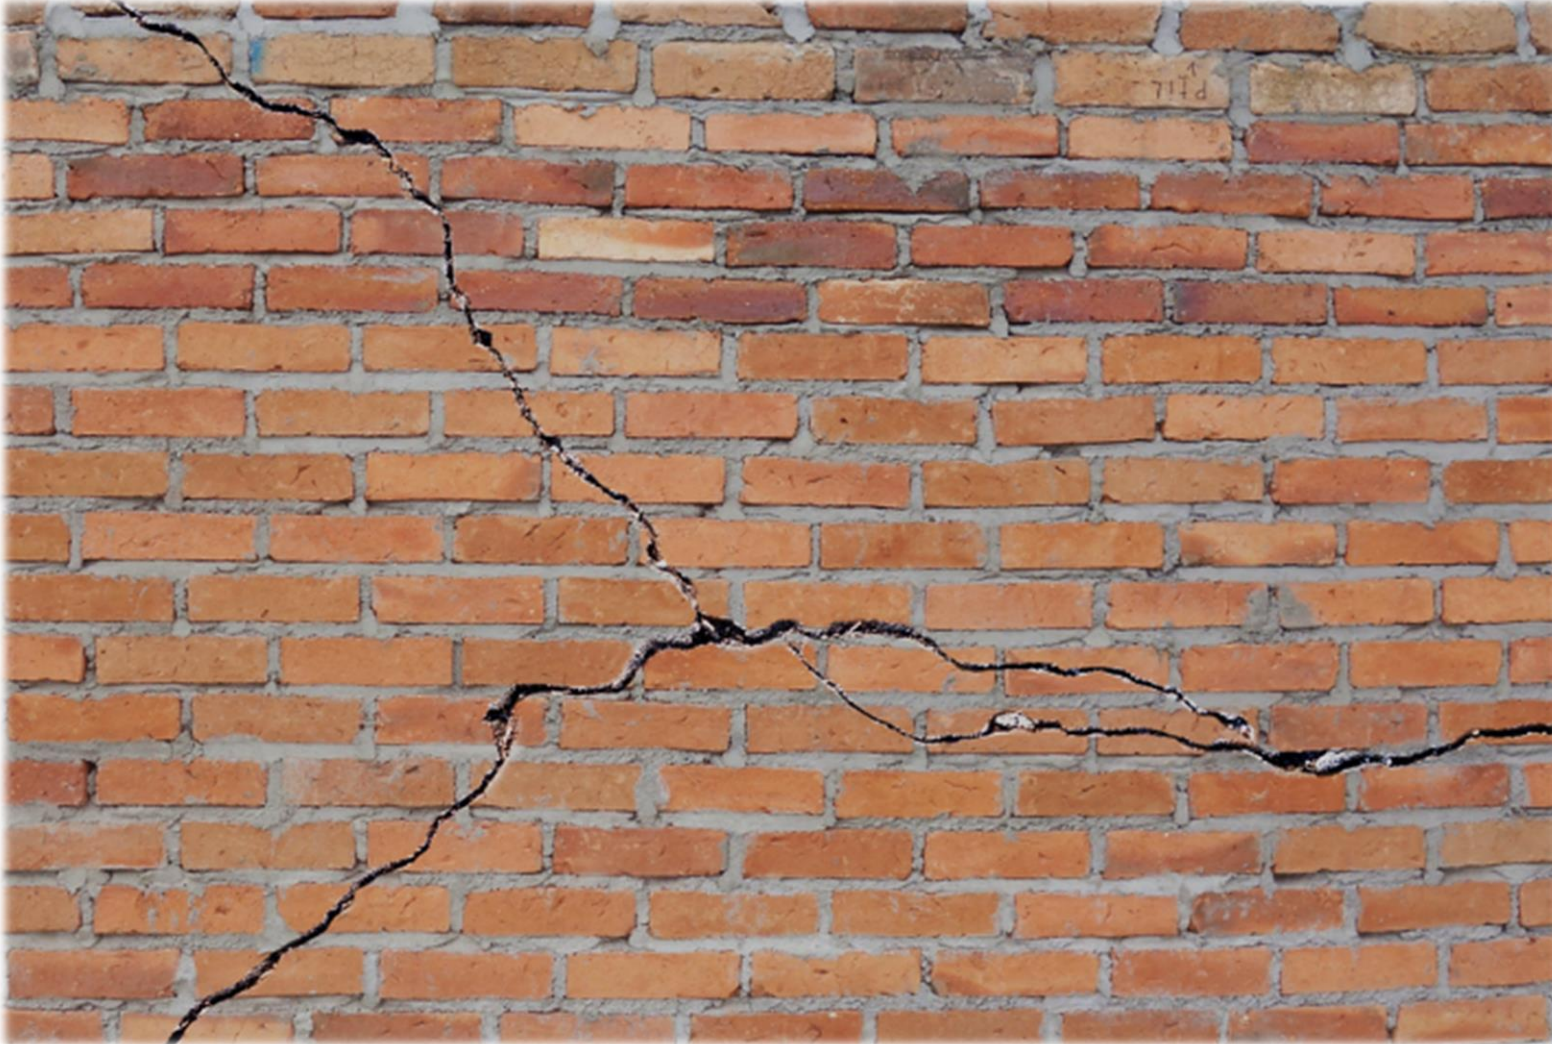
Median value	16 th - 84 th percentile	Proposed range
DS1	-	-	0-0.30
DS2	0.33	0.14-0.74	0.30-0.60
DS3	0.9	0.6-1.2	>0.60

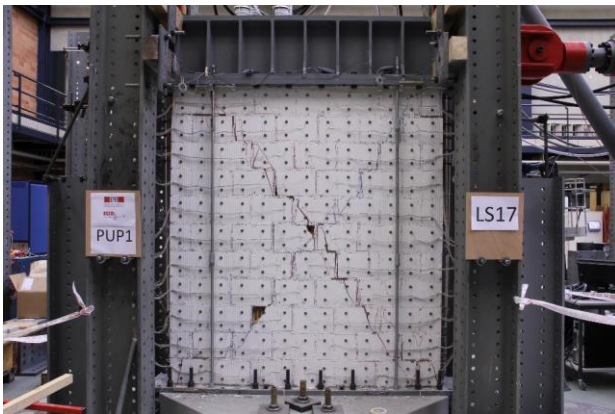
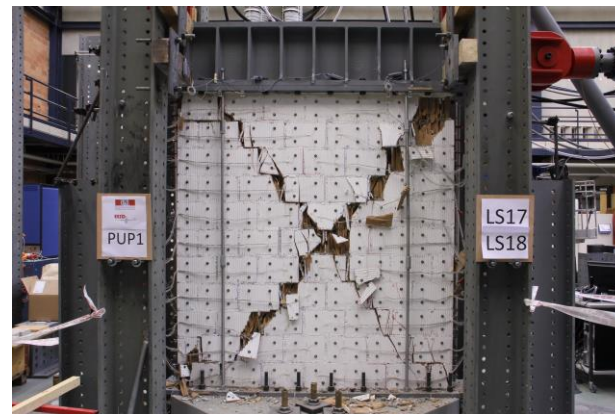
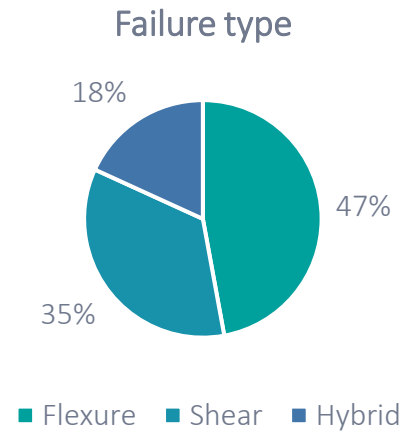
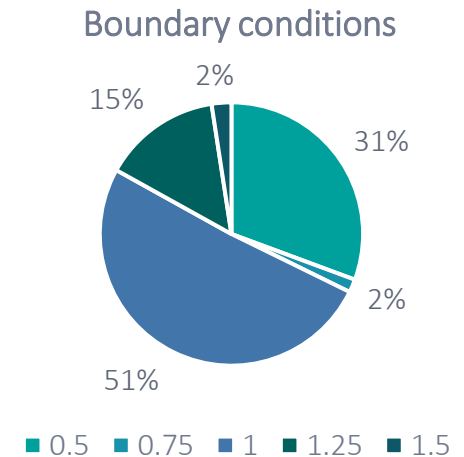
Pier database

- Database for piers consists of around 100 non-linear static tests.
- About 25 detailed data (progression of damage during the test is given).

Detailed damage information during test available	
Crack measurements	9
Photographic/descriptions	6
Sensor	14
Optical sensors	11

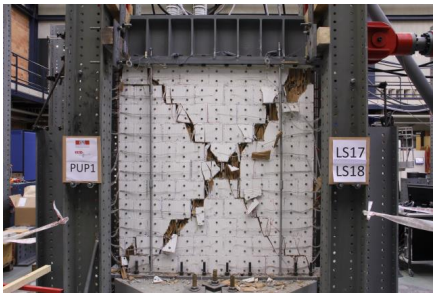
- The DI parameters β and γ are calibrated using all available tests at collapse

- Using the hysteretic energy and drifts from tests at collapse.

*Photo from Petry and Beyer, 2014

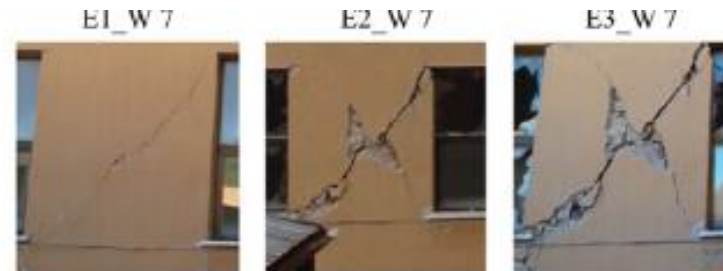
- Attempted on shake table tests but most exhibit flexural failure on elements, and have incremental levels of shaking.
- Building model of Visso School, damaged during the 2016 Central Italy sequence.
 - We know the ground motions at the site (instrumented).
 - There is survey information about the damage after each event. Progressively more damaged.
 - We have the Equivalent Frame model (Tremuri software).

*Photos from
Brunelli et al, 2021

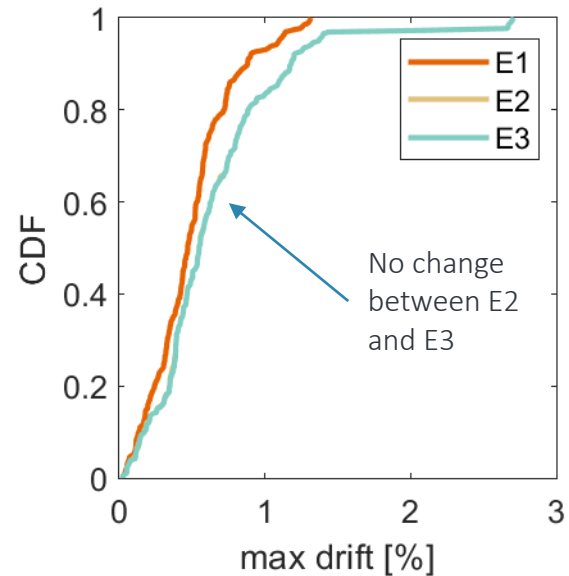
Per element:

- We see an increase of damage on the elements after each shock, drift-based/global metrics cannot capture this.
- Tends to overestimate slightly, however there is some uncertainty in the observations for the first 2 shocks (only photos) and improvements are still possible.

Observed			Simulated		
X		Y	X		Y
E1	E2	E3	E1	E2	E3
2	3	3	2	3	4
			3	4	4
