# FAITHFUL REHABILITATION

*History, culture, religion, and engineering all intertwined in a recent project in Jerusalem to rehabilitate and strengthen the site believed to be the tomb of Jesus of Nazareth. Modern methods, including 3-D laser scanning, nondestructive testing techniques, and ground-penetrating radar, combined with careful documentation, revealed the secrets of how to help preserve and sustain the ancient site for future generations.*

**BY THE NATIONAL TECHNICAL UNIVERSITY OF ATHENS  
INTERDISCIPLINARY TEAM FOR THE PROTECTION  
OF MONUMENTS AND CONTRIBUTING AUTHORS**

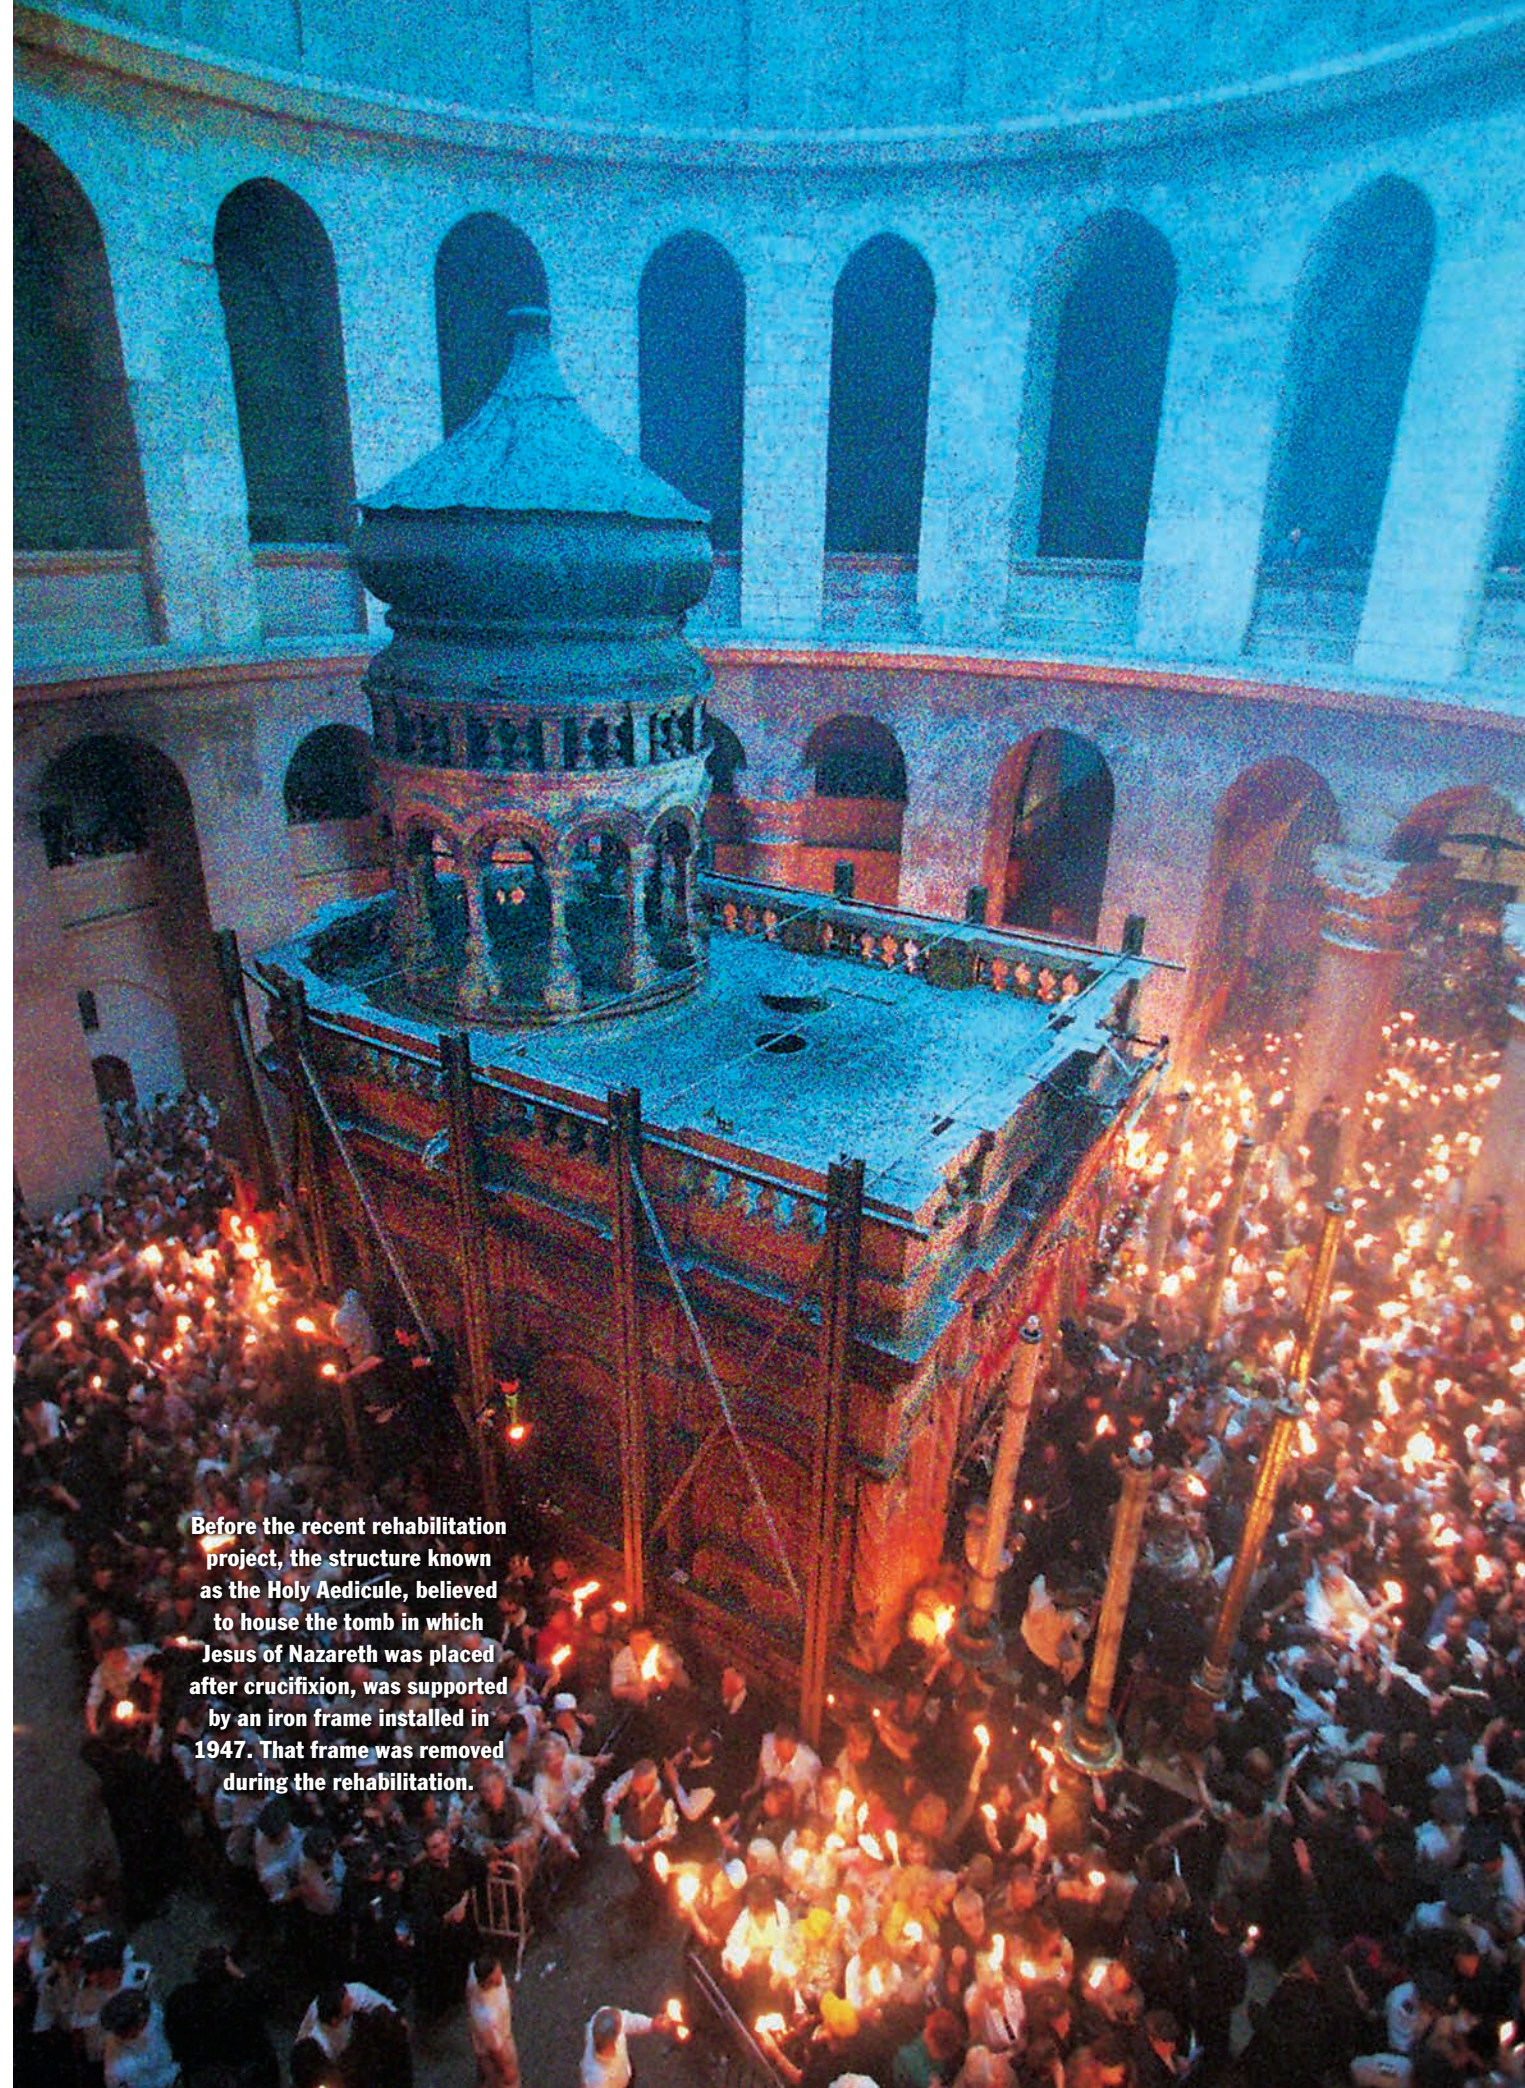
Before the recent rehabilitation project, the structure known as the Holy Aedicule, believed to house the tomb in which Jesus of Nazareth was placed after crucifixion, was supported by an iron frame installed in 1947. That frame was removed during the rehabilitation.

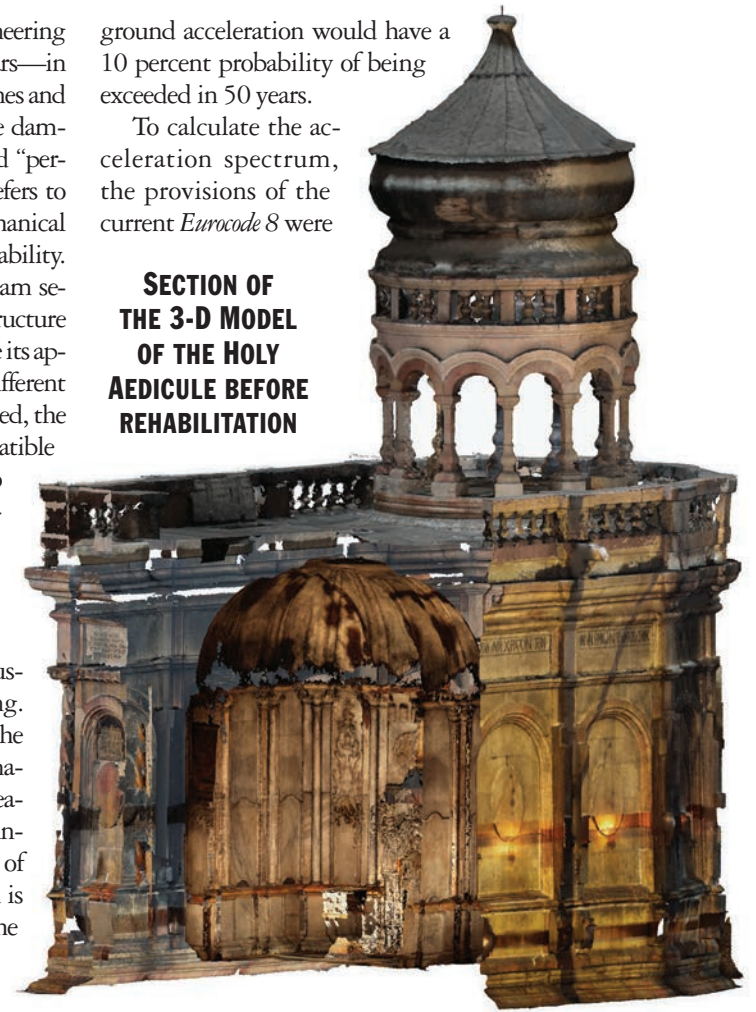
**SECTION OF THE 3-D MODEL OF THE HOLY AEDICULE BEFORE REHABILITATION**

This 3-D model of the Holy Aedicule was created using image-based techniques and terrestrial laser scanning. The production of the high-resolution model enabled the team to extract the necessary conventional 2-D information. For example, highly accurate specific geodetic measurements were correlated for all areas within the Rotunda—the large, circular space within the western end of the Church of the Resurrection, at the center of which is located the Holy Aedicule—to determine how much the columns of the aedicule had deviated from vertical. Additionally, a combined study involving ground-penetrating radar and architectural analysis was performed to reveal the internal layers of the aedicule and to determine the different construction phases.

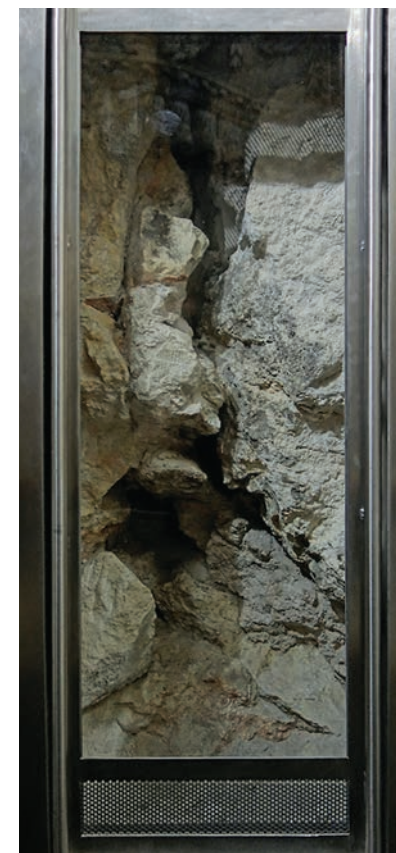
**The opening of the Holy Tomb involved lifting a marble plate, above. A glass window, below, was installed at the south wall of the interior of the tomb to provide views of the Holy Rock.**

on which Jesus's body is believed to have been placed. During the grouting procedure this surface was protected from grout flow, which preserved the monument's significance while also ensuring the longevity of the site. A window-like opening was also created in the interior wall opposite the tomb to control the grouting at the south interior area.
