USING GEODETIC AND LASER SCANNER MEASUREMENTS FOR MEASURING AND MONITORING THE STRUCTURAL DAMAGE OF A POST BYZANTINE CHURCH

Demitris Delikaraoglou, Andreas Georgopoulos, Charalabos Ioannidis,
Evangelia Lambrou, George Pantazis
School of Surveying Engineering, National Technical University of Athens,
9, Iroon Polytechniou str., 15780 Athens, Greece

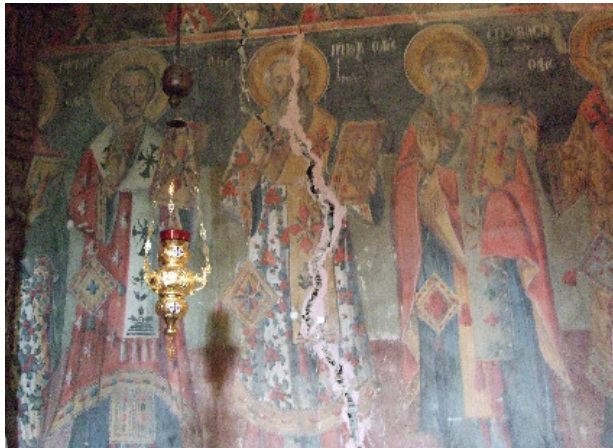
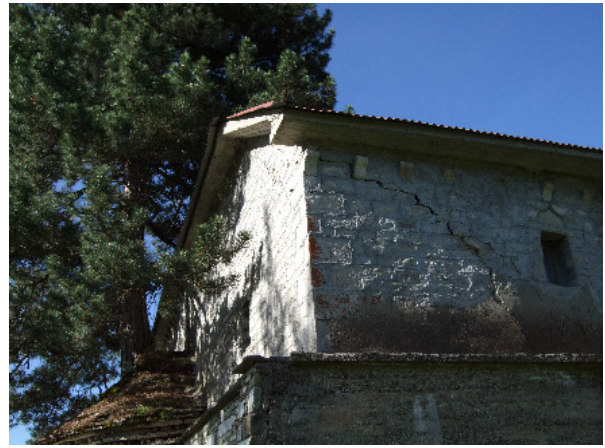
Figure 2: Typical examples of damage caused by structural deformation in the interior (left) and the exterior (right) of the church of Megali Panayia in Samarina

Wintertime is very harsh in Samarina. The geological and geomorphological characteristics of the greater area around the village are considered to play a vital role in the various geotechnical problems, i.e. severe cracks, which have made their appearance on a number of houses and other constructions and stone works, and inevitably contribute to similar structural problems on the Church of Megali Panayia. Continuous rainfalls and snow cover, causing soil erosion and ground loading effects, are considered to be additional causes of structural problems, which have occurred to the church over the past few years. Large visible cracks inside and outside of the building, as the examples shown in Figure 2, have alarmed the curators of the monument and have caused severe worries concerning the security of the building and that of the pilgrims. Hence some immediate action is considered imperative. However, before any maintenance intervention, a quantitative analysis of the evident and likely critical deformations of the church building was deemed to be of utmost importance. Therefore, before deciding upon the best possible solution for the support of the damaged monument and the engineering measures to be taken for preventing the risk of possible sliding of the building due to the soil erosion, a highly accurate geodetic network for monitoring over a period of time the deformations of the church building and the surrounding ground was considered necessary. The main objecting was, through the synthesis of various types of repeated measurements and the variations of the coordinates of observed points, to detect and monitor the building's deformations through time and relate any changes in its geometry to likely terrain displacements and the rebounding of the terrain caused by the winter induced variations of the underground water levels in the surrounding area of the monument.

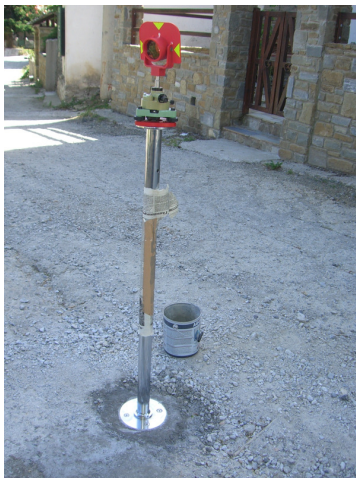
Figure 4: Special markers for the network points

The monitoring geodetic network which was established around the church is composed of special permanent markers, namely semi-portable pillars (Figure 4), for setting for positioning the various instruments used (e.g. GPS receivers, electronic theodolites and total stations), nine more station points in the church’s interior, marked using small brass benchmarks floor (Figure 5) and of permanent survey targets on the walls of the church, both inside and outside, that were set up in different places where identity, pointing accuracy and permanence could be ensured. The former type of markers was selected so that to ensure high repeatability of the measuring process, in terms of minimising any centering errors during the instrument setting over the markers each measuring period. A special procedure was used in order to measure precisely ($\pm 0.3\text{mm}$) the instrument height over each pillar (Lambrou et al, 2007). The targets for the points on the walls were specialized retroreflective tape targets (Figure 6), which would ensure accuracy of $\pm 1\text{mm}$ in distance measurement. Their exact positions were decided with the co-operation of specialized architects and civil engineers, who would eventually use and exploit the results of the measurements of the repeated surveys (Figure 5). They were durable, nondestructive, stable and insensitive to external influences (temperature variations, corrosion and moisture) and they were suitably chosen so that not to cause any damage to the church walls and be barely visible to the uninformed observer.

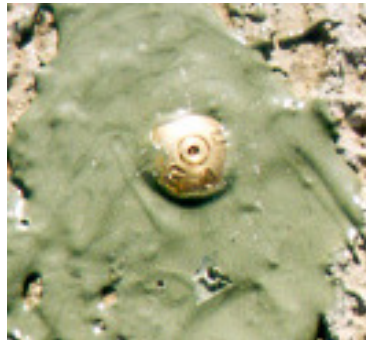
Figure 5: Station point inside the church

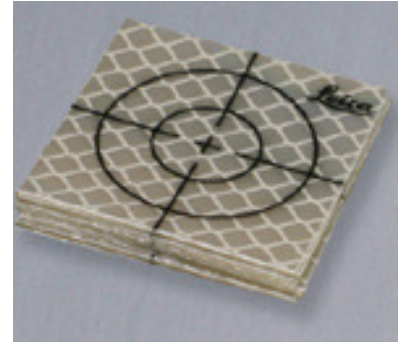
Figure 6: Special retroreflective tape targets

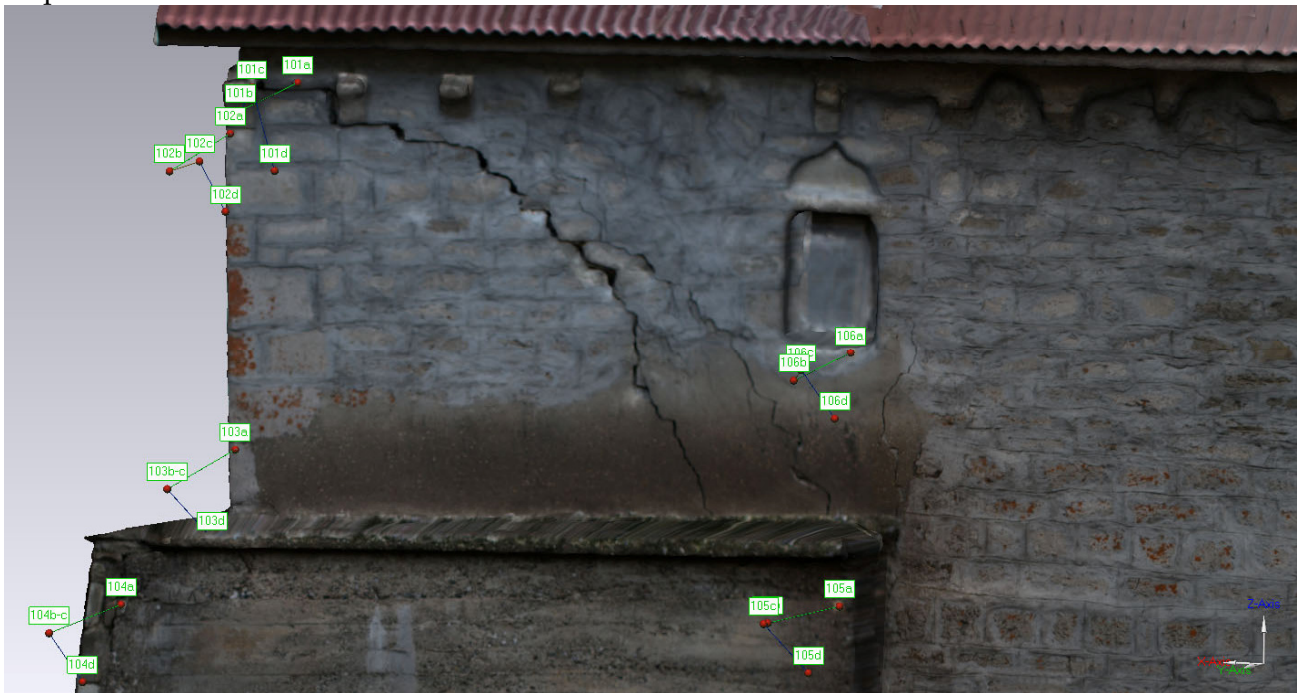
Figure 10: Part of the external northern façade

The exterior surfaces of the 3D model were rendered using the high resolution registered digital images and the points on the walls were positioned on the VRML version of the 3D model, using little spheres, in the Geomagic software. For the representation of the displacements, linear vectors were used with different colour for each period interval and with an exaggerated scale, e.g., 50 times. The result is shown in Figures 10 and 11. In Figure 10 part of the rendered 3D model of the external northern façade is shown, with several point positions and the displacements between the observation periods. In Figure 11 an enlargement of an area of the same façade is presented and the displacements between observation periods are also shown. It is remarkable how similar these displacements are.
