# Documentation of the Leprosarium of Chios

In this paper the procedure of the documentation of the Leprosarium of Chios Island, is presented. First established in 1378, took its final form in 1933 and abandoned in 1959 is one of the longest-term health institutions of Greece. The very interesting building complex, in terms of historical and architectural value, was classified as a protected historical monument, in 2011. However, this was not enough for the protection of this important monument, as today it is completely abandoned.

The paper focuses on the geometric documentation of the Leprosarium, carried out with contemporary combined methods (e.g conventional reflectorless total station, geodetic GNSS, close-range photogrammetry, aerial measuring methods, etc).

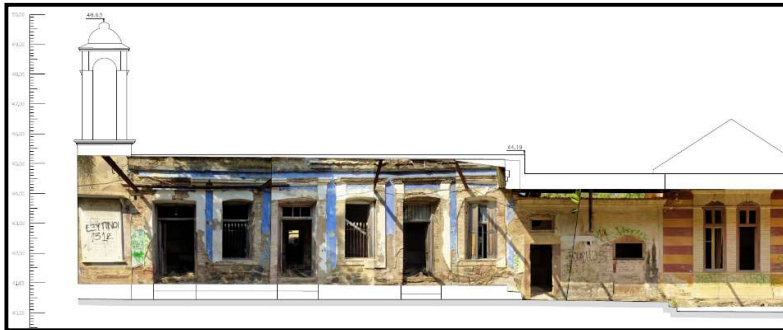
**Fig. 6.** Orthophoto of the south façade

- 1 orthophoto of the south façade with precision of the scale 1:50. (fig 6). It complements the south façade plan, giving more information about the materials used and condition and the pathology of the façade.

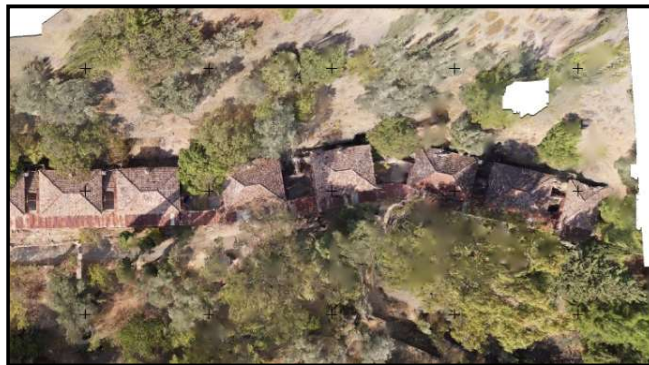
**Fig. 7.** Orthophoto of the complex

- 1 orthophoto of the complex with precision of the scale 1:200 (fig 7), complementing the topographic plan.

For the creation of the orthophotos 80 photos were taken and 100 points were measured as GPSs.
