### Beyond the boundaries of feasible engineering geological solutions: stability considerations of the spectacular Red Beach cliffs on Santorini Island, Greece

V. Marinos<sup>1</sup> · G. Prountzopoulos<sup>2</sup> · P. Asteriou<sup>3</sup> · G. Papathanassiou<sup>1</sup> · T. Kaklis<sup>1</sup> · G. Pantazis<sup>4</sup> · E. Lambrou<sup>4</sup> · N. Grendas<sup>1</sup> · E. Karantanellis<sup>1</sup> · S. Pavlides<sup>1</sup>

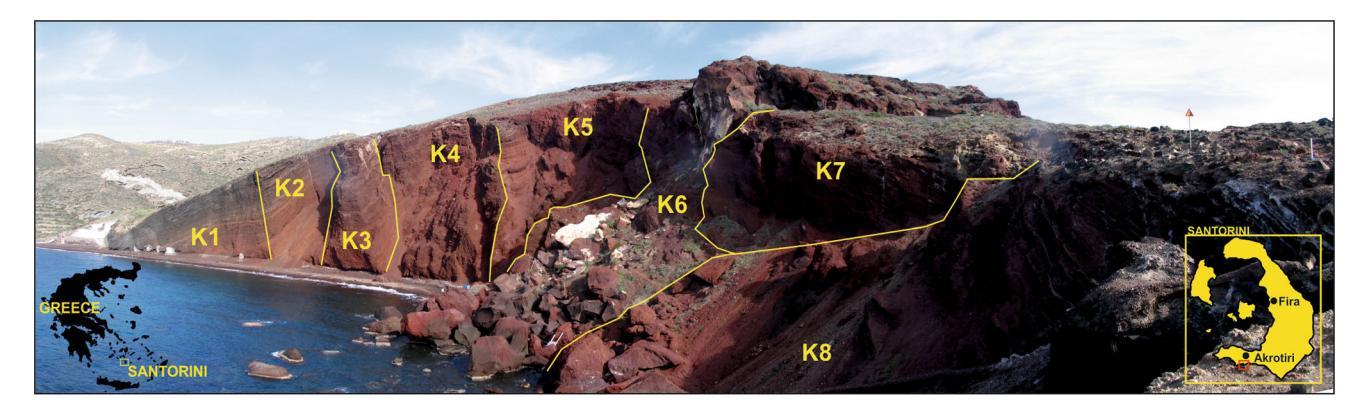
The length of the beach is approximately 300 m, while its width varies from 4 to 10 m, and it is strongly affected by sea erosion. Access to the beach is permitted via a small rocky path from a car parking area that follows a steep topography with high slopes. A view of the Red Beach cliffs and a depiction of the zonation (K1–K8) used for an assessment of the rockfall hazard are illustrated in Fig. 2.

Fig. 2 Location and view of the Red Beach cliffs, where rock falls present with episodic characteristics. The zonations (K1-K8) used to delineate rockfall potentials are illustrated

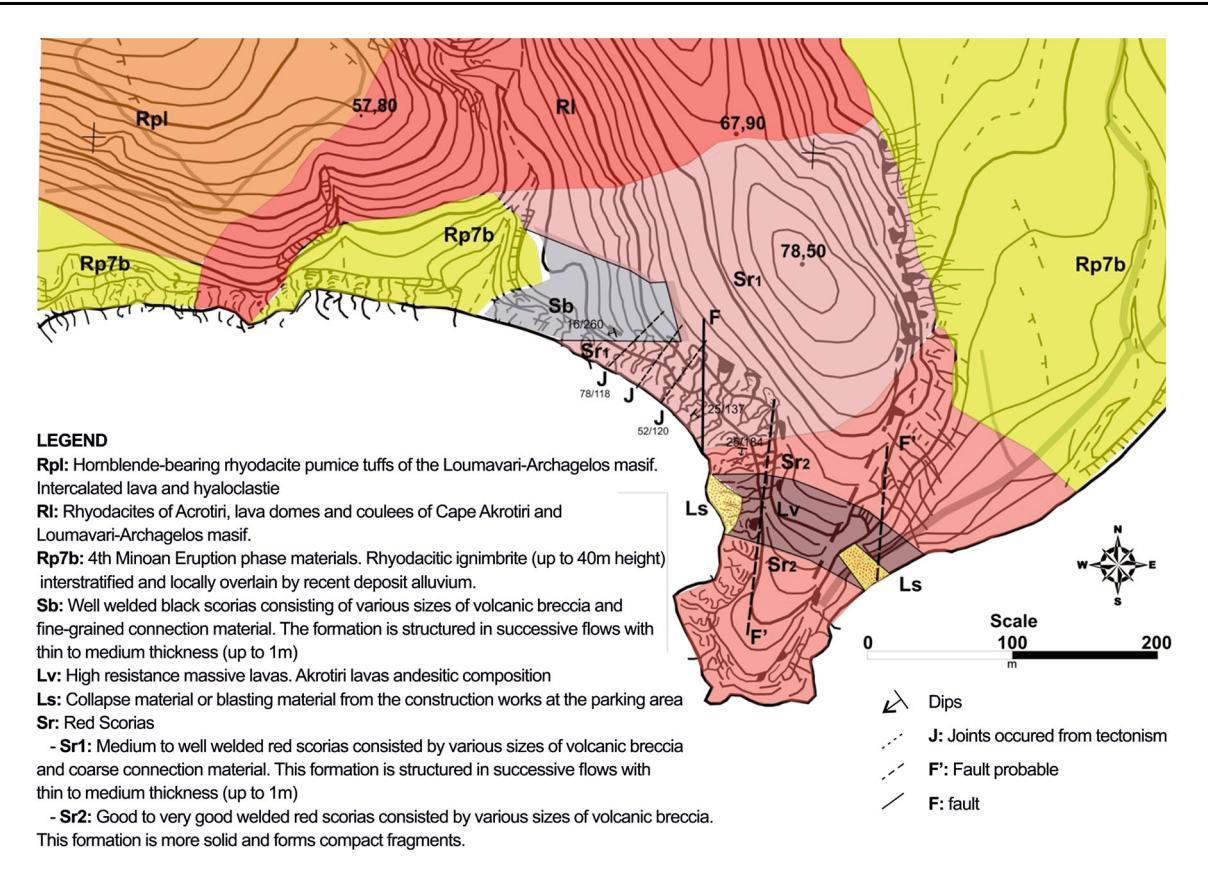
Based on the petrography, the structure and the degree of cementation, and the structural attributes, the area is divided into five zones as shown in Fig. 5. As illustrated in Fig. 4a, the red scoria (Sr) is a medium- to well-cemented geological unit (Sr<sub>1</sub>) (Fig. 5) consisting of the same type and size of material as the black scoria. A section located adjacent to the volcanic vent (Lv) exhibits a geological unit consisting of scoria that is well- to very well-cemented (Sr<sub>2</sub>), the formation of which is compact and creates more distinctive blocks of rock. The black scoria (Sb) consists of highly cemented, angular lapilli-sized pyroclasts and finegrained material, which are structured into successive flows of thin to medium thicknesses on the order of approx. 1 m. Within both geological formations, lava fragments (e.g., bombs of variable diameter and shape) may be present.

Fig. 5 Engineering geological map of the area developed for the purposes of this study. The geological formations are modified from Davies et al. (1999)

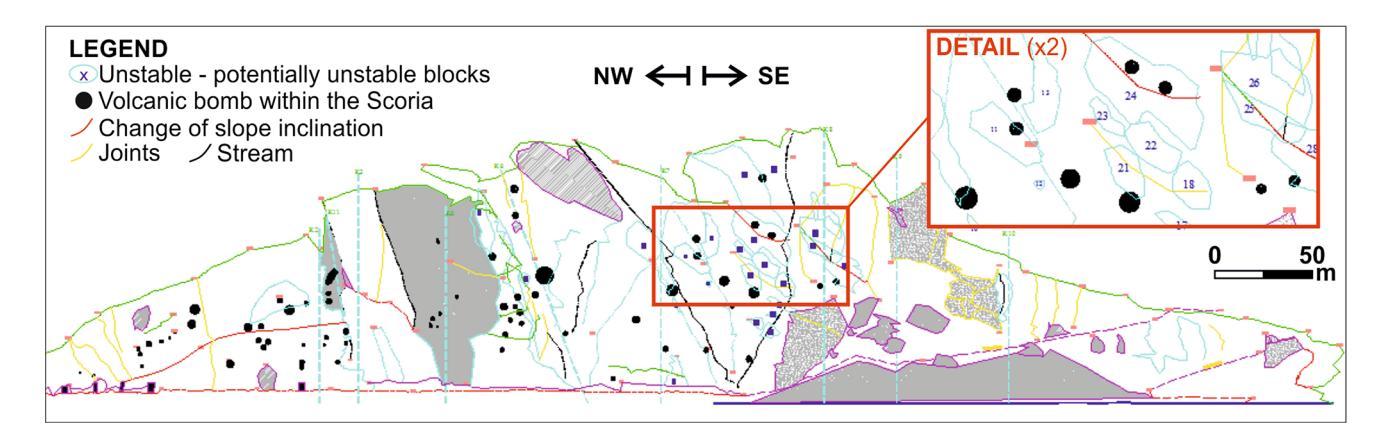
The field survey observations were acquired by collecting appropriate measurements of characteristic detailed points, one-by-one, which encompasses all of the rock formations within the declivity. The particularity of the case, as well as the inaccessibility of the areas defined by exceedingly steep slopes, necessitated the use of reflectorless total stations (Pantazis and Nikolitsas 2011). These instruments measure remote and inaccessible points using a laser beam. Thus, all the significant characteristics at the foot and the top of the declivity, including major cracks, large rock masses, rock crevices and peaks, rock discontinuities, undermined areas, unstable or detached rocks, and overhanging rocks, are illustrated on a façade plan (Fig. 9).

Fig. 9 Facade of the declivity of the Red Beach cliffs (please see the corresponding explanation in the text)
