A SLOPE STABILITY CASE IN ARCADIA: Case Narrative

Highway on the move (EN) – Αυτοκινητόδρομος εν κινήσει (EL)

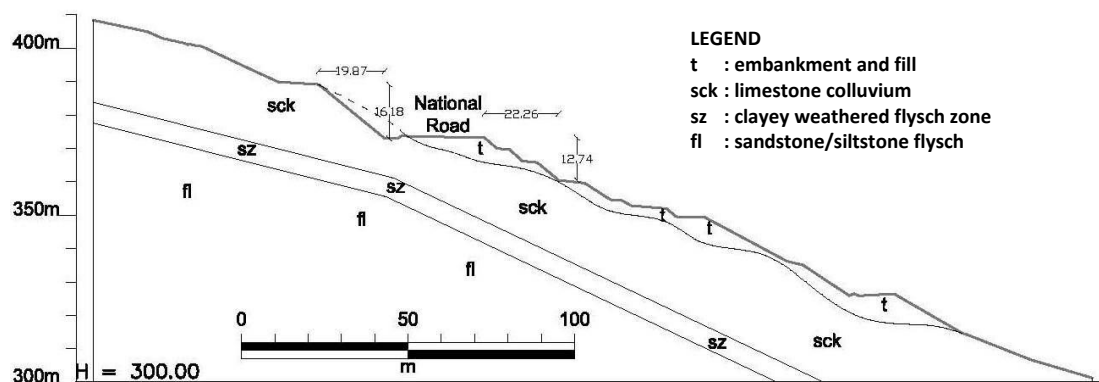
Figure 1: Cross section of the embankment area.

As a young engineer in a consulting company working for the ministry, you are asked to do these calculations for a cross section constructed partly on embankment and partly cutting through the colluvial material, as shown in **Figure 1**. Geological mapping covers a zone extending from 150 to 250 m on either side of the road. Geotechnical investigation is focused on problematic areas and in areas where large cuttings or embankments are designed. The geotechnical cross section of Figure 1 is a typical result of such an investigation. The major units are limestone colluvium, about 20- to 35-m thick, and flysch, separated by a zone of clayey weathered flysch.
